Appendix D: Notice of Intention to Demolish 93 West Street

Notice of Intention to Demolish - 93 West Street City of Brantford's Heritage Register as a Non-Designated, Listed Property

Re: Existing Residences
MN 93 West Street
Brantford, Ontario
Condition Review

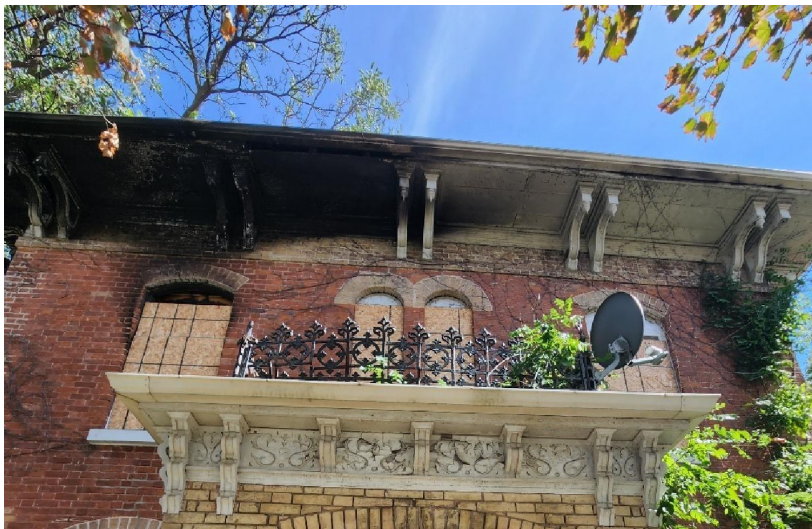
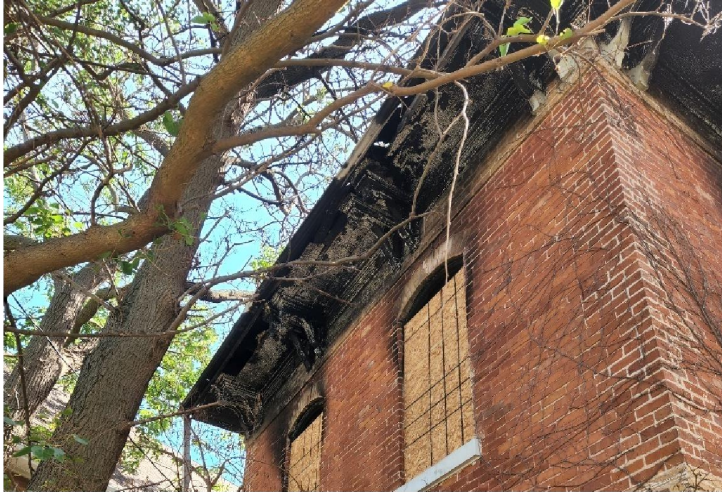
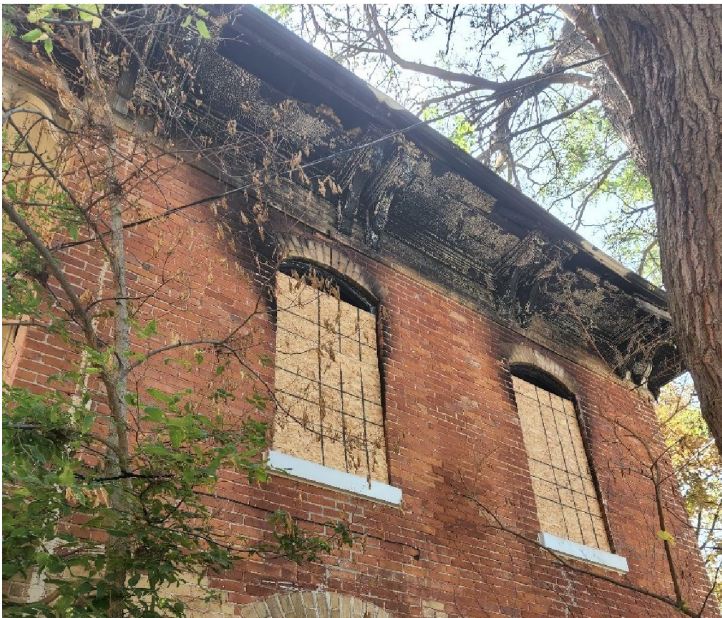
Figure 4: Fire Damage at 93 West Street (September 2, 2022)

The Property has been vacant since November 2021. The Property has been subject to unknown trespassers, including those that are responsible for a fire at the Property. The fire caused significant damage to the interior and exterior. The fire has damaged the Italianate features, identified by the heritage registry, beyond repair. Prior to the fire, the exterior of the Property was in disrepair, but the fire has escalated the poor condition of the building.

The Property owner states that the building which was previously deemed beyond repair by J.H. Cohoon Engineering has further surpassed any possibility of repair. The fire at the Property has exacerbated the poor structural integrity of the building and any heritage value.

The fire at the Property since May 2021 has further destroyed the Italianate features of the Property such that the soffits, fascia and brackets have been completely removed on the North and West side of the building and caused substantial damage to the building (refer to **Figure 3**).

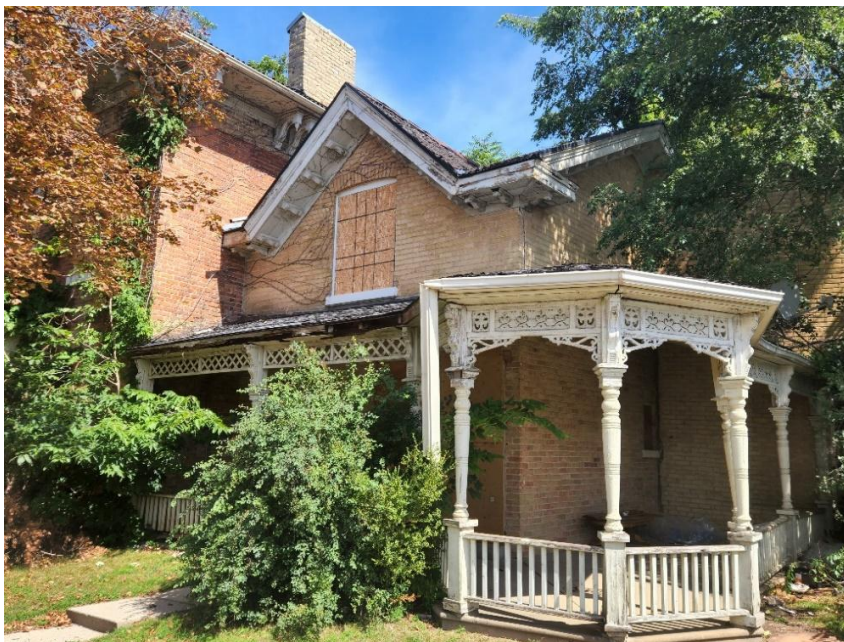
Figure 4: 93 West Street – Building Addition (September 2, 2022)

characteristics consistent with the 1850's. The addition can be seen relatively easily from the street of the Property and poses different brick and style.

The characteristics of the South side of the Property does not align with the style of residences in the 1850s. The porch of the addition suggests that the addition was added after the incorporation and approximately in the late 19th century. The Property owner notes that the porch contains features, such as wood spindles and detailed trim that are more akin to late Victorian era.

the characteristics of the front porch are not typical with residences with an age dating back to the 1850's but it likely an add on feature to the residence during more recent times.

As mentioned, the Property has an addition that poses features and style that does not align to the Italianate architectural style, but rather that of the late 19th century. The addition and altered style from the original building is visible from the street and substantial in nature.

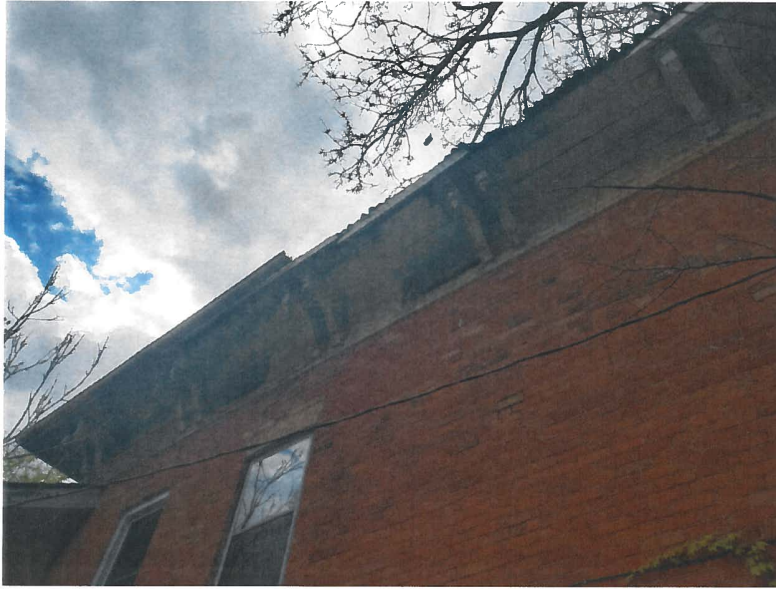
Photo No. 1 – Picture of Exterior Soffit and Brick Wall

The soffit and fascia on this building has deteriorated with substantial wood rot having occurred. The building does not have eave troughs and downspouts that are functioning on this building.

Portions of the Brick Walls are in need of re-pointing.

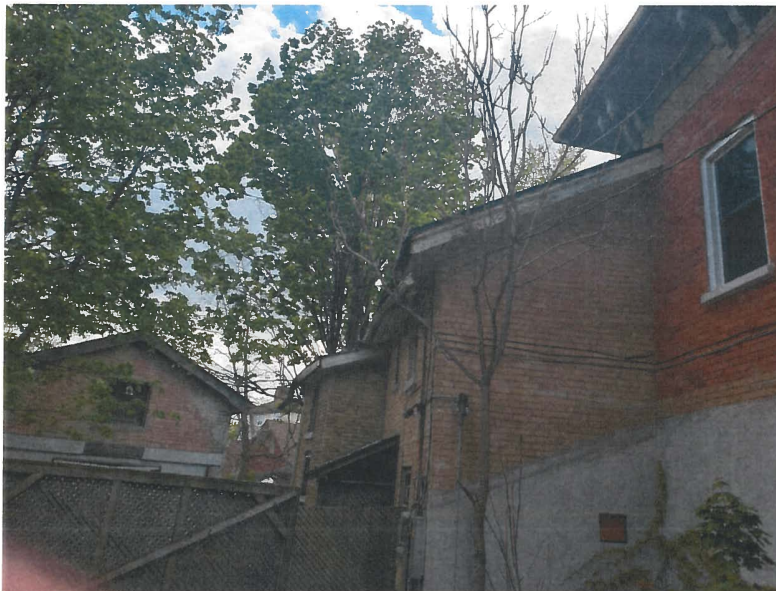
Photo No. 2 – Picture of Rear of the Subject Building.

The picture illustrates the deterioration of the exterior features. Lack of Eave trough, and general Condition of the structure.

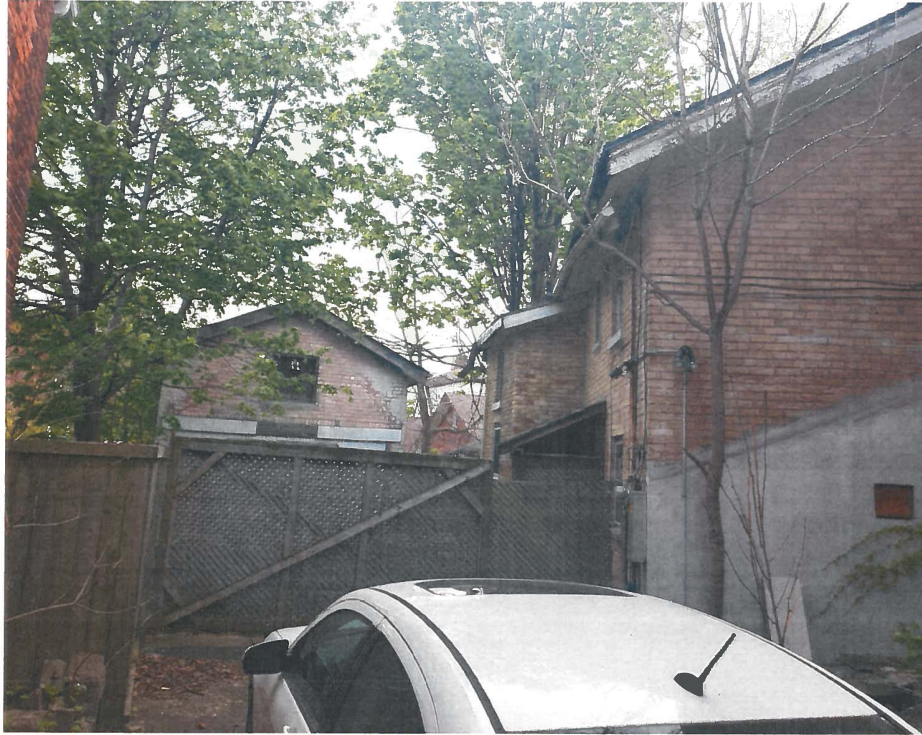
Photo No. 3 – Similar to Picture No. 2

The picture illustrates the deterioration of the exterior features. Lack of Eave trough, and general Condition of the structure.

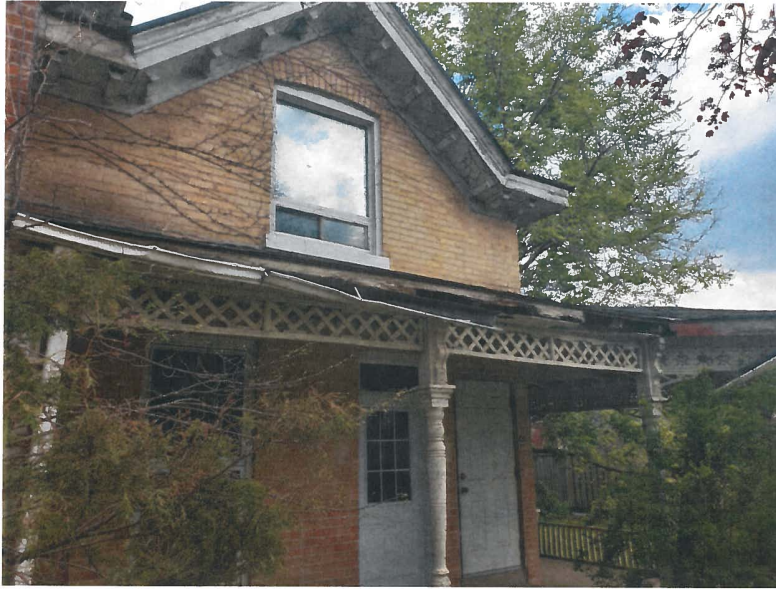
Photo No. 4 – Picture of Front Veranda of the Residence

The roof structure is showing signs of deterioration. The Soffit and eaves have rotted away. The Roof structure has deteriorated to the point that substantial deflection of that structure is occurring.

Brick Cracking has been seen in the picture. The remaining portions of the Brick Walls are in need of re-pointing.

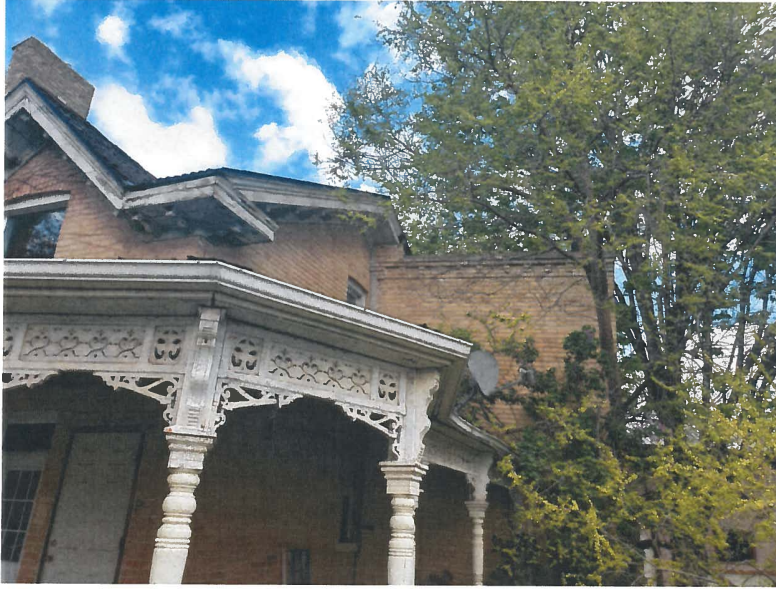
Photo No. 5 – Picture of Front Veranda of the Residence

The roof structure is showing signs of deterioration. The Soffit and eaves have rotted away. The upper soffit and fascia are also showing signs of deterioration without eaves and downspouts being present.

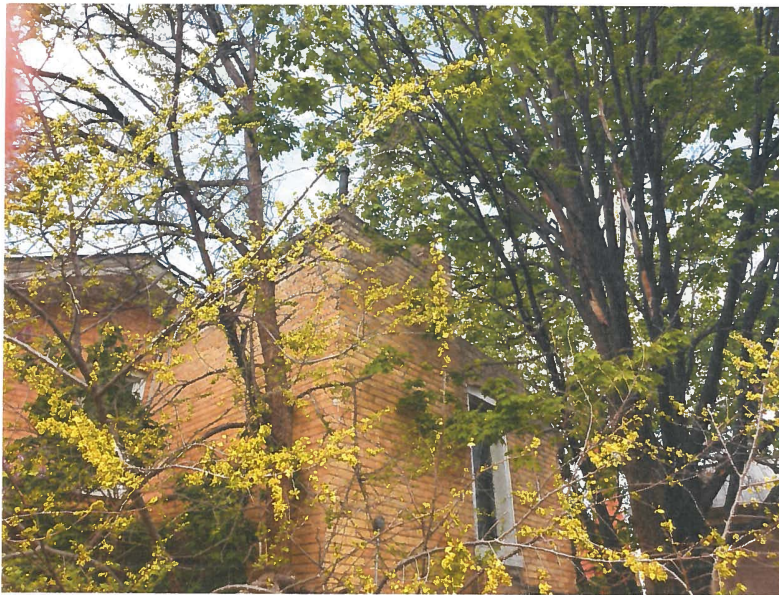
Photo No. 6– Picture of North wall of the Residence

The brick work of the structure is being shown.

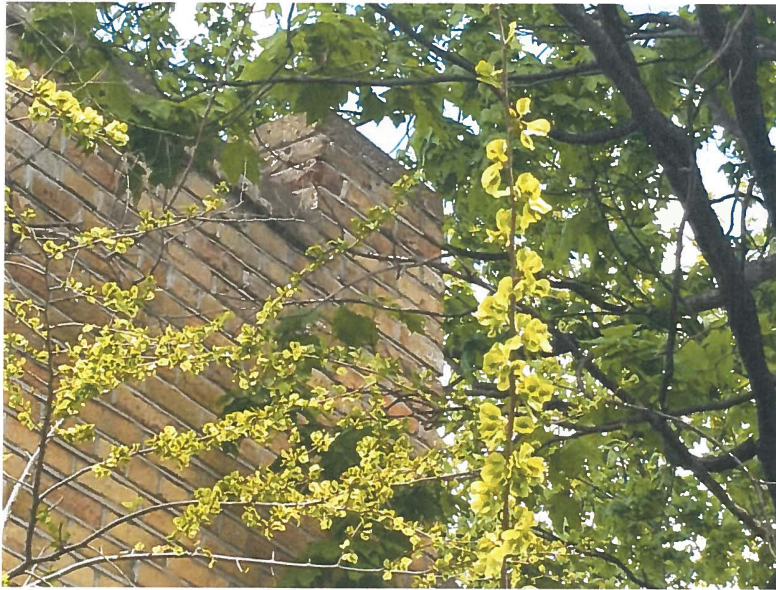
Photo No. 7 – Picture of condition of the brick work on portions of the building.

The brick is showing the need for being repaired and repointed.

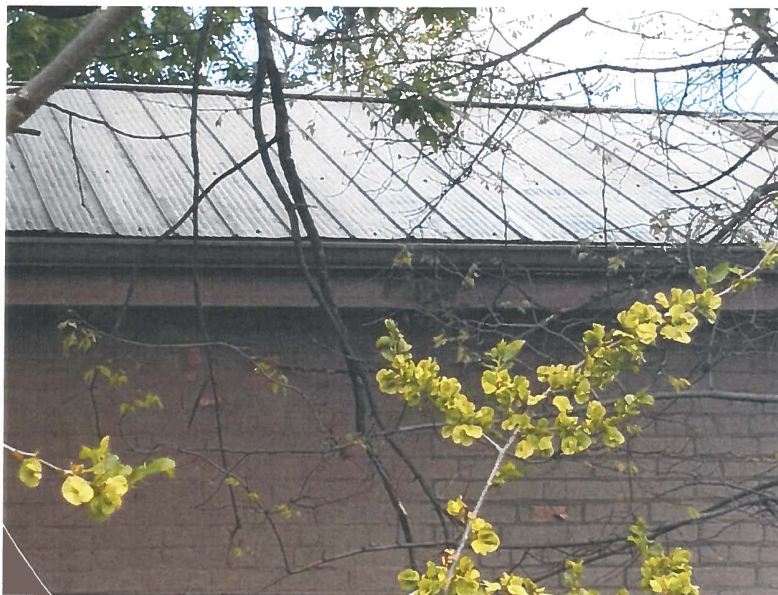
Photo No. 8 – Picture of Rear Garage of the Property.

The garage is located on the property and encroaches onto the neighbouring property. The roof although being a metal roof membrane is showing some signs of distress with the deflection of portions of the roof. This appears to be a result of the deterioration of

the under-roof structure (although access to the garage was not available at the time of our inspection).

The brick work of the garage structure is being shown which illustrates that this is also in the need of repair and re-pointing.

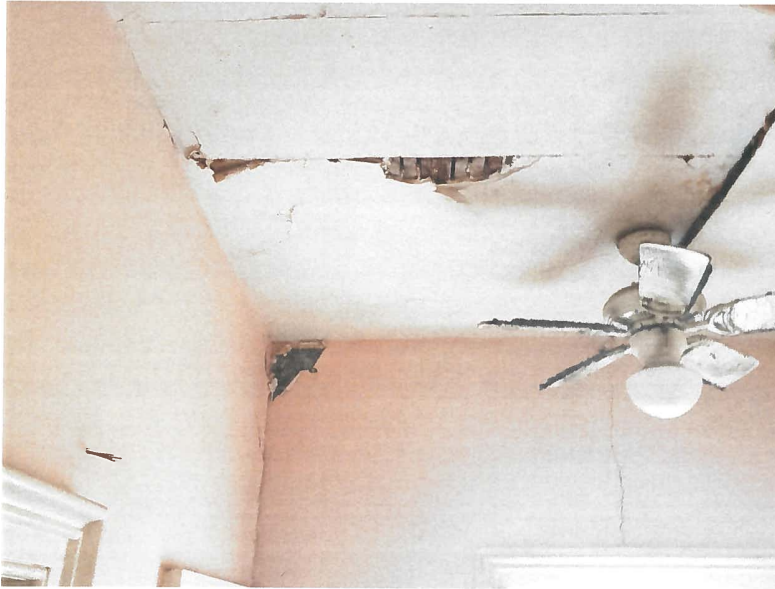
Photo No. 9 –Interior Picture of the upper dining area.

Water damage is apparent that in this locations whereas the plaster has fallen off the underlying lath structure. This is evidence of the water penetration of the roof structure into the residence.

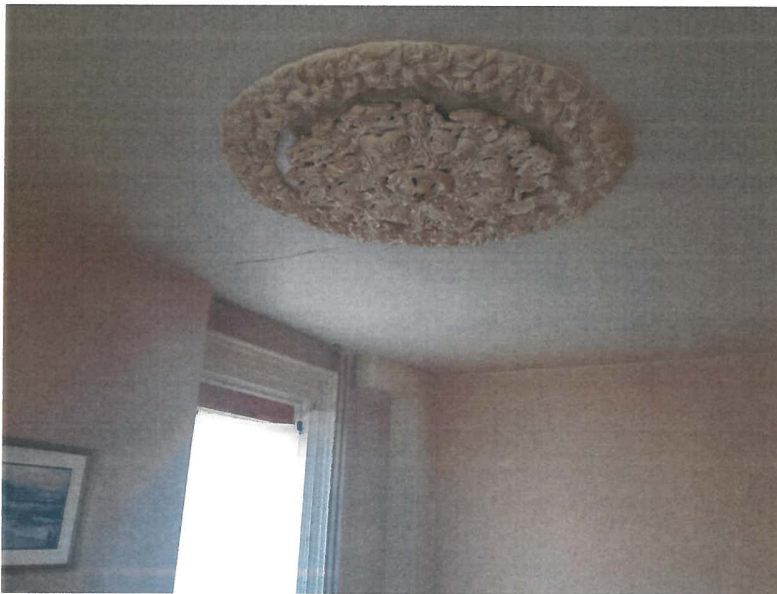
Photo No. 11 – Additional Picture of the Interior of the Residence

The cracking in the ceiling appears to be as a result of water entry

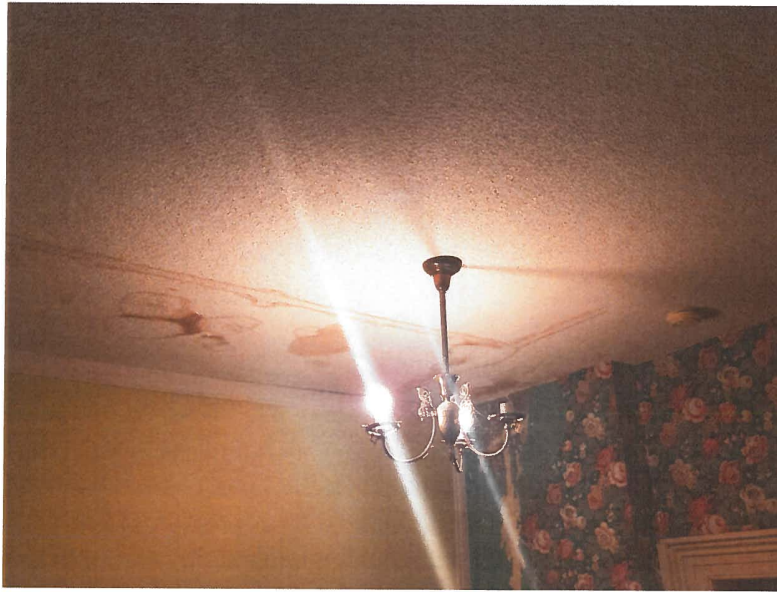
Photo No. 12 – Picture of interior of the Residence

These photos indicate that water damage is occurring throughout the residence. The roof membrane / asphalt shingles are not providing the protection for the water entry into the building

The ceiling is experiencing deterioration as a result the penetration of water into the residence.

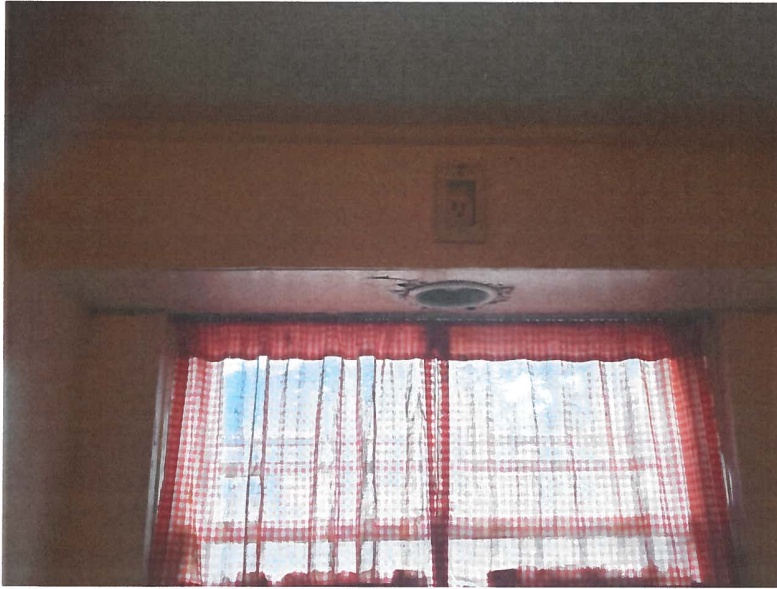
Photo No. 13 – Additional picture of interior of the Residence

These photos indicate that water damage is occurring throughout the bulkhead over the window. The entry of the water is likely as a result of the roof system deterioration.

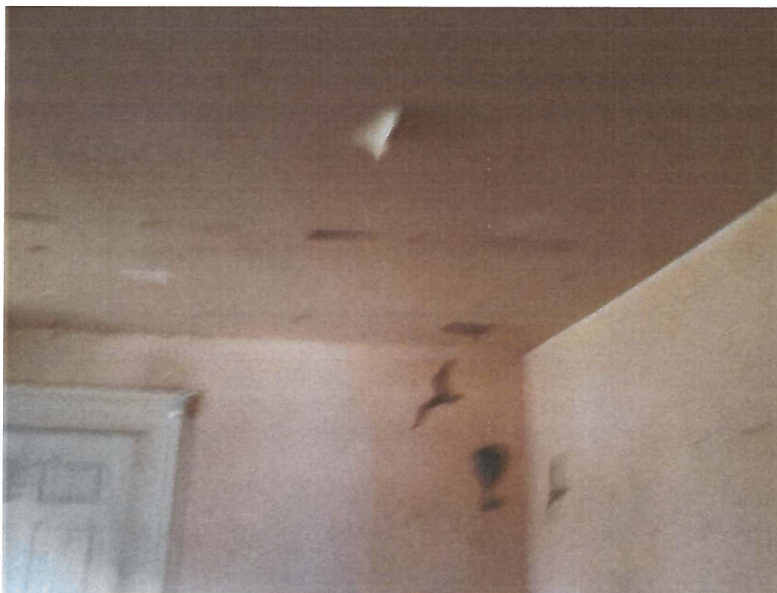
Photo No. 14 – Picture of interior of the Residence

Again, the water penetration into the structure is resulting in the deterioration of the interior finishes

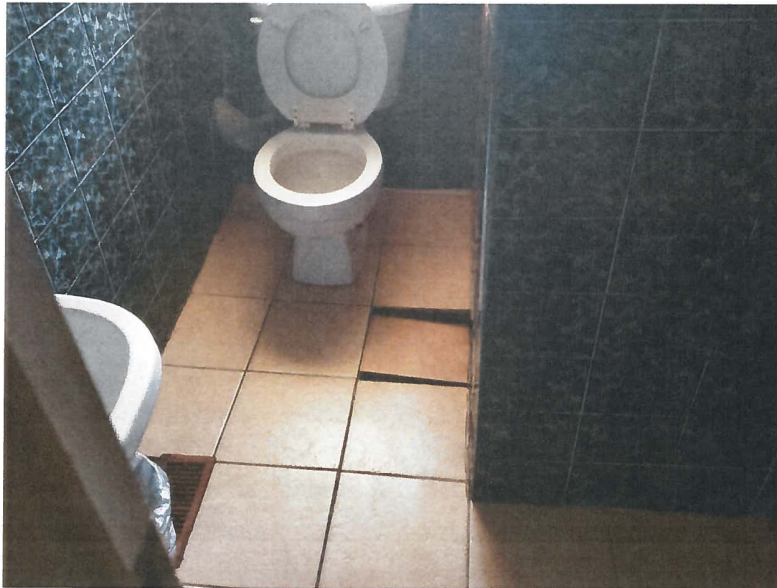
Photo No. 15 – Picture of interior Washroom (Upper level)

The photograph indicates an issue with the structure of the floor within the bathroom. We would anticipate that water penetration into the structure is affecting the structure of the building resulting in the displacement of the tile

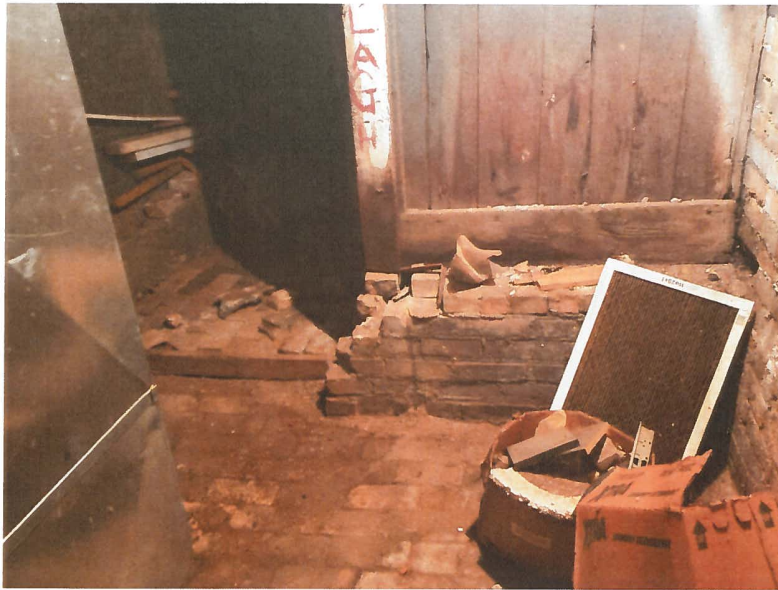
Photo No. 16 – Picture taken in the basement of the residence

The basement / foundation is a brick foundation that has been modified over the years

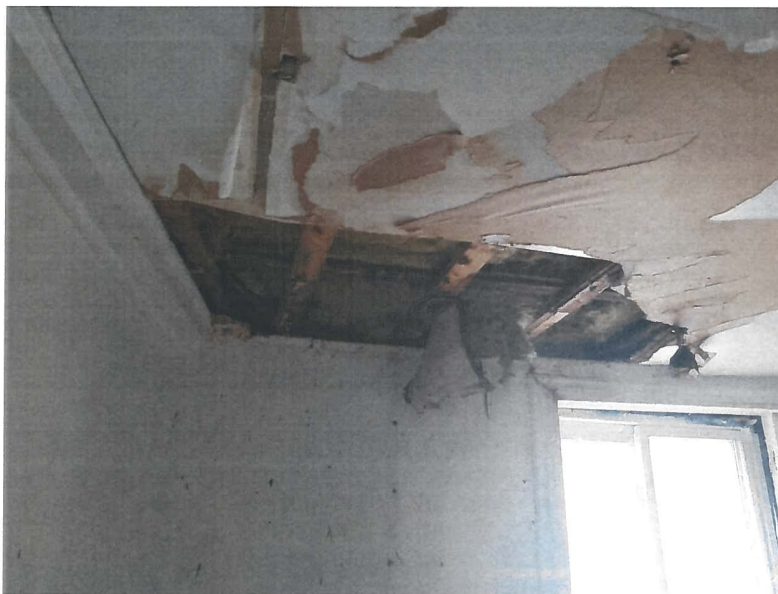
Photo No. 19 – Picture of interior of the Residence

These photos indicate that water damage is occurring throughout the residence. The roof membrane / asphalt shingles are not providing the protection for the water entry into the building

The ceiling is experiencing deterioration as a result the penetration of water into the residence and is collapsing in places.

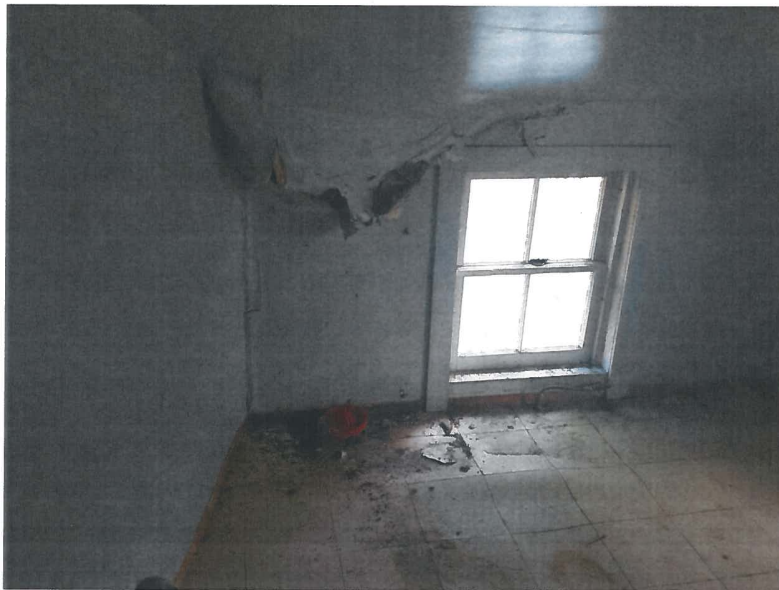
Photo No. 20 – Picture of interior of the Residence

These photos indicate that water damage is occurring throughout the residence. The roof membrane / asphalt shingles are not providing the protection for the water entry into the building

The ceiling is experiencing deterioration as a result the penetration of water into the residence and is collapsing in places.

Further evidence of lack of protection of the interior of the residence.

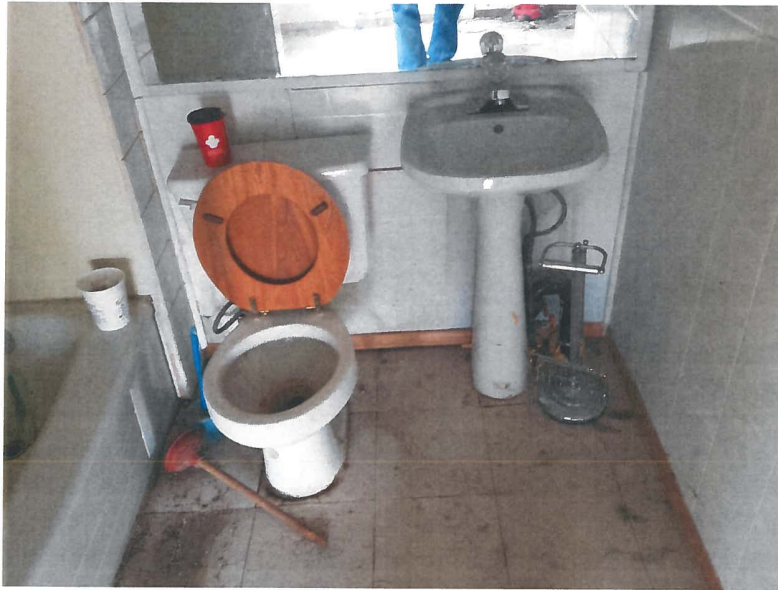
Photo No. 21 – Picture of interior of the Residence (Upper Washroom)

These photos indicate a lack of maintenance of the interior of the residence / units. Damage to the interior finishes is occurring as a result of the lack of maintenance.

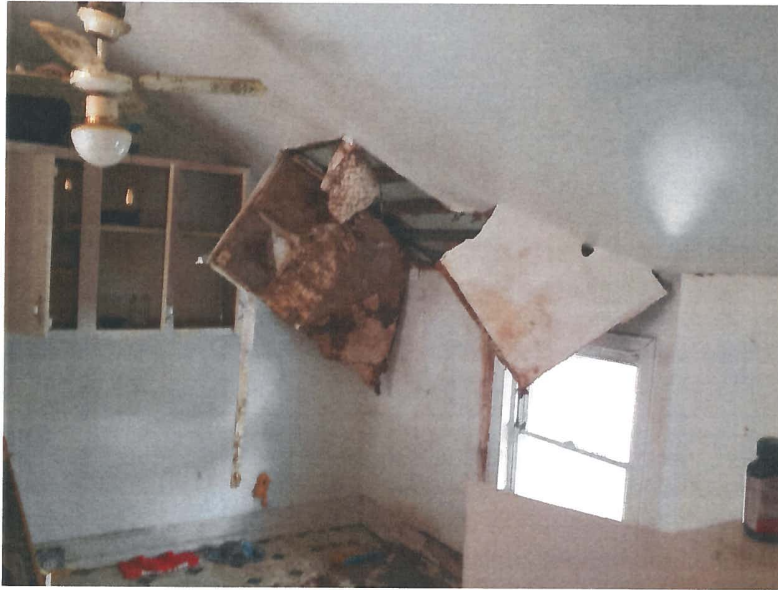
Photo No. 22 – Picture of interior of the Residence

These photos indicate that water damage is occurring throughout the residence. The roof membrane / asphalt shingles are not providing the protection for the water entry into the building

The ceiling is experiencing deterioration as a result the penetration of water into the residence and is collapsing in places.

Further evidence of lack of protection of the interior of the residence.

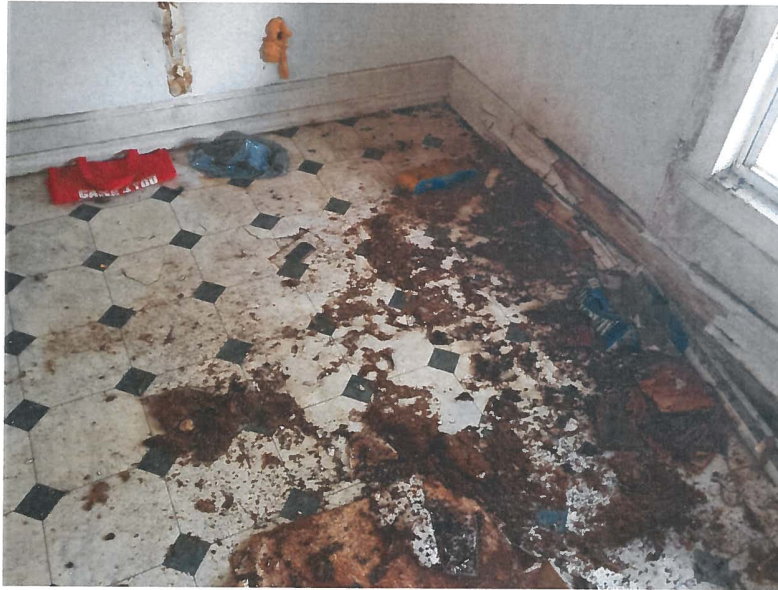
Photo No. 23 – Picture of interior of the Residence

This photo is taken in the vicinity of those areas whereas the ceiling is collapsing. The roof membrane / asphalt shingles are not providing the protection for the water entry into the building

The ceiling is experiencing deterioration as a result the penetration of water into the residence and is collapsing in places.

The insulation and roof materials are falling into the residence.

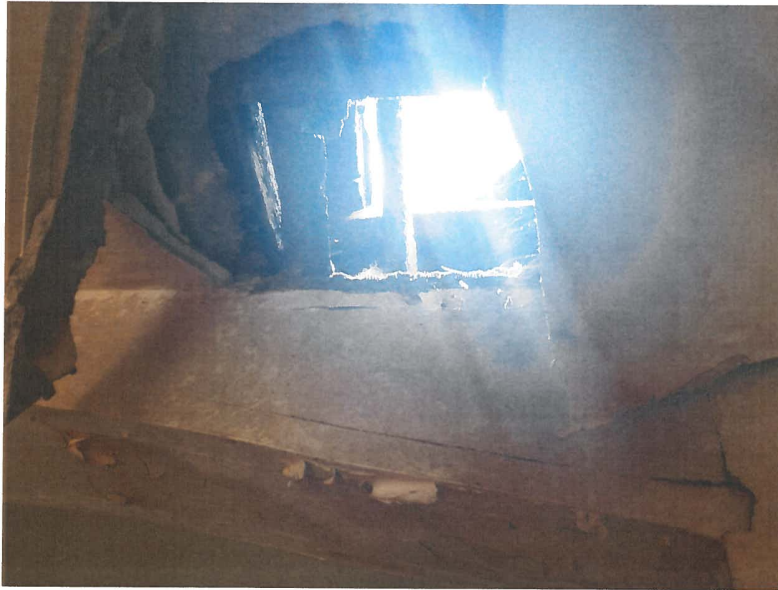
Photo No. 24 – Picture of interior of the Residence

These photos indicate that water damage is occurring throughout the residence. In fact, holes in the roof are resulting in the deterioration of the interior finish. No protection in these areas to prevent water from entering the structure

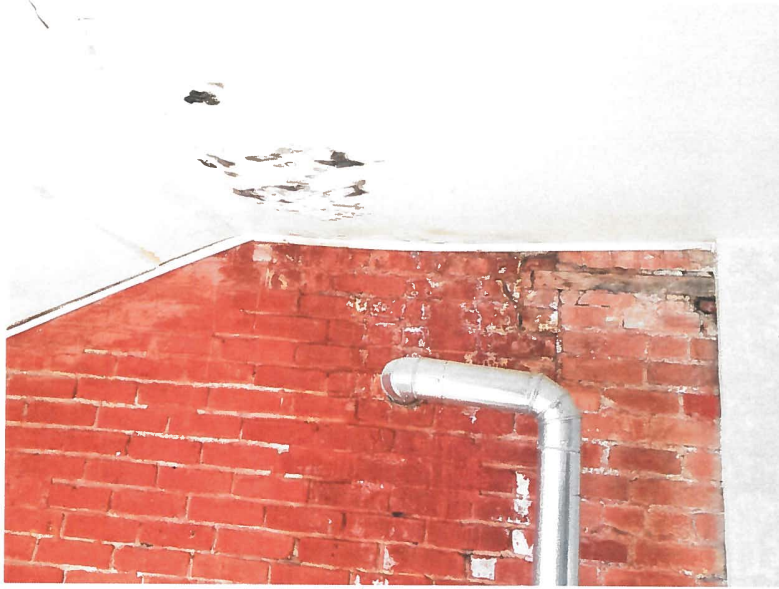
Photo No. 25 – Picture of interior of the Residence

This picture indicates the water damage that is occurring to the ceiling membrane as indicate in a series of photographs. In addition, brick staining is evidence that water is entering the interior and running down the walls. The white efflorescence is evidence of the water entry. The brick (likely a bearing wall in the structure) is in need of re-pointing and repair.

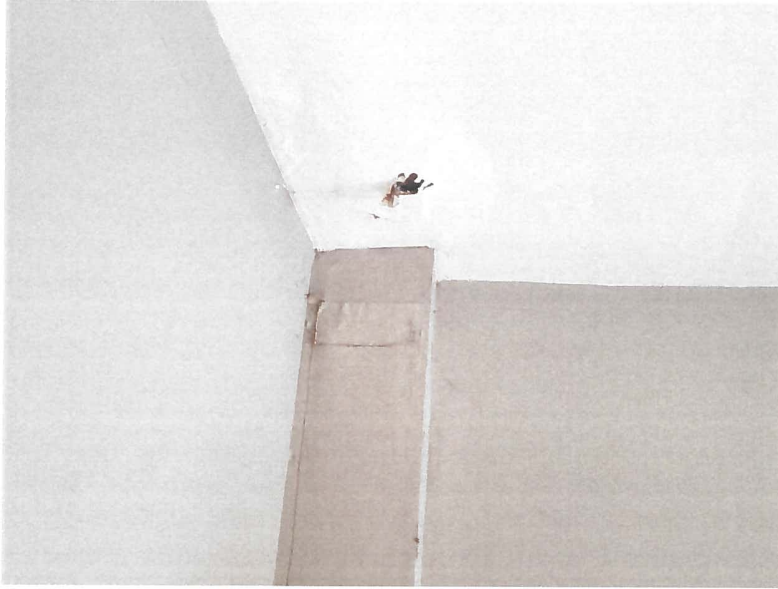
Photo No. 26 – Further evidence of water penetration in the upper levels of the residence.

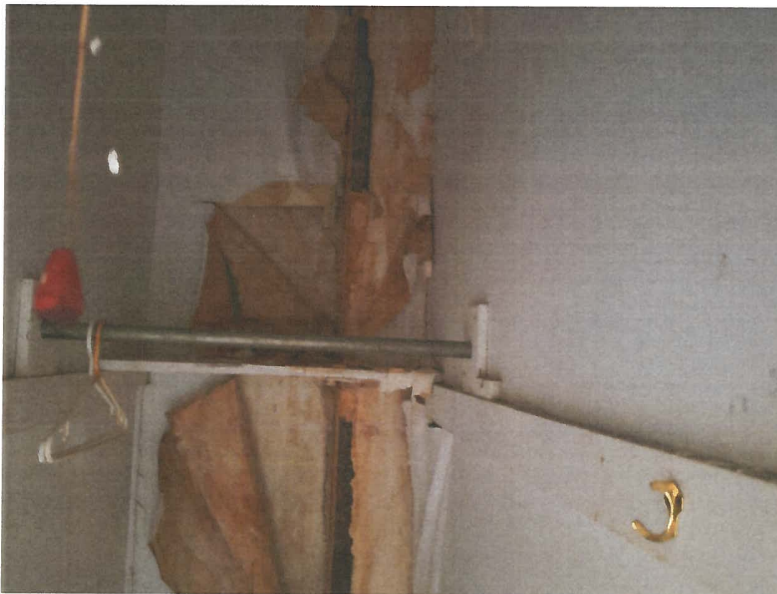
Photo No. 27 – Further evidence of water penetration in the upper levels of the residence.
