TIME KEEPER'S OFFICE AND PORTICO BUILDING REVIEW REVISION 1

Prepared For:
Corporation of the City of Brantford

Project Number
2023-213

Date Submitted
October 11, 2023

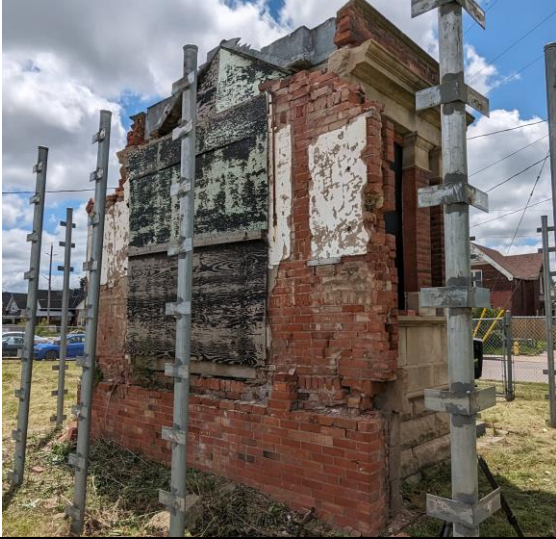
ELEMENT	OBSERVATIONS	COMMENTS	REF. PHOTOS
FAÇADE	– Significant brick and mortar joint cracking and deterioration	– Significant cracking and deterioration of bricks and mortar joints was found along all elevations, with the majority being along the back (North) elevation.	1,4
	– Displacement of stones and missing mortar	– The lower façade stones along the front elevation of the building appears to be displaced with a visible gap present in multiple locations.	2
	– Large area of damaged loose bricks at back (North) of the Portico structure	– Due to the method of demolition to the previously attached/adjacent structure, there is a large area of damaged loose bricks at the back of Portico. This will need to be addressed and re-built wholistically and fully, and in a method which is accessible to the design intent of this building. This item should be discussed further prior to providing a recommendation to City of Brantford Staff.	-

Photo 1: Cracking, deteriorated masonry and joints.

- Provide masonry repairs/replacements to the areas of deteriorated masonry and tuckpointing – **BUDGET \$60,000**
 - There is currently a small inventory of potentially matching bricks stored in the Time Keeper's Office. These bricks should be closely compared to existing and used to source more bricks as necessary for all required repairs.

- Special attention should be paid to the characteristics of the existing mortar and repair material sourced to match.
 - Displaced stones should be repositioned and pointed.

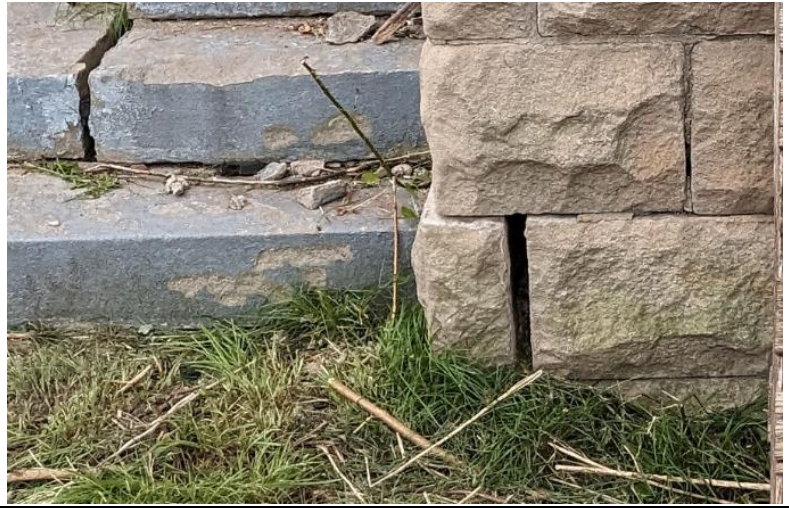
Photo 2: Displaced lower stone and missing mortar.

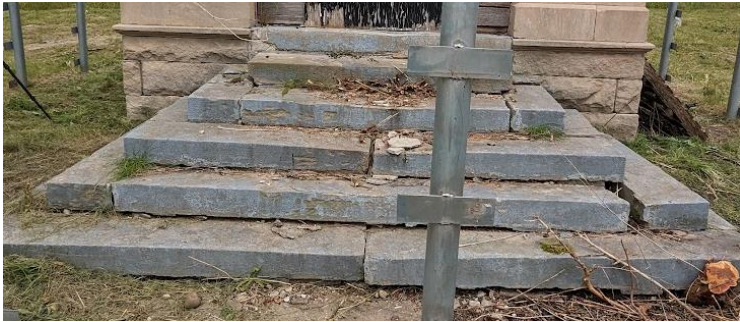
ENTRANCE	– Cracking, deteriorated stone steps	– The entrance steps had several through cracks and vegetation growth between steps, the extent of which is unable to be verified until removal.	3
ROOF	– Not accessible	– Further investigation and access are needed to the interior of the structure to determine any potential ceiling/roof structural concerns.

Photo 3: Cracked, deteriorated stone steps.

- Provide removal and reinstallation of entrance stair stones – **BUDGET \$40,000**
 - Remove existing front stones in a method which allows for maintenance of condition and re-use of the stone stairs.
 - Regrade and provide an adequate base (concrete or granular) for the existing stones to be reinstalled.
 - Reinstall removed existing stones to match existing size and shape of stairs.

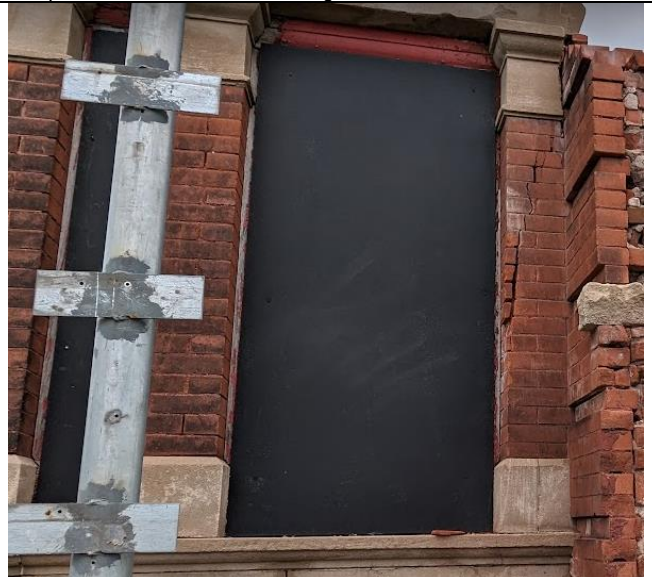
Photo 4: Boarded window and cracking brick

- Sand, stain, and apply protective finish to exterior window and door frames. Replace to match any portions of wood that are rotten and have lost structural integrity.
- Replace existing plywood with black painted new marine-grade plywood as per Property Standards By-law (Article 29, Section 4) .

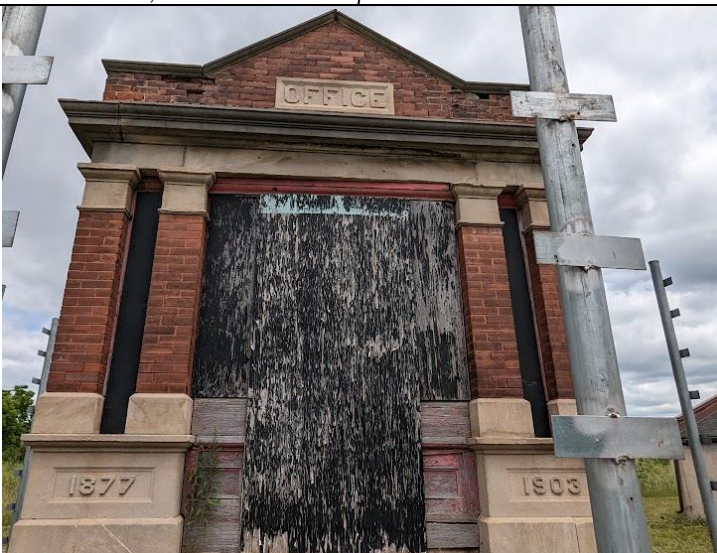
WINDOWS AND DOORS	– Deteriorated wood lintel	– A deteriorated wood lintel was noted above a West window opening as observed from the exterior ground level. This lintel appears to be aesthetic.	-
	– Boarded, sealed windows	– Window openings were boarded, and the majority of windows not exposed for review, however the visible portions did indicate wear and deterioration.	4
	– Boarded, sealed door	– The entrance door opening was boarded, and the majority of the door not exposed for review, however the visible portions did indicate wear and deterioration.	5

Photo 5: Boarded door.

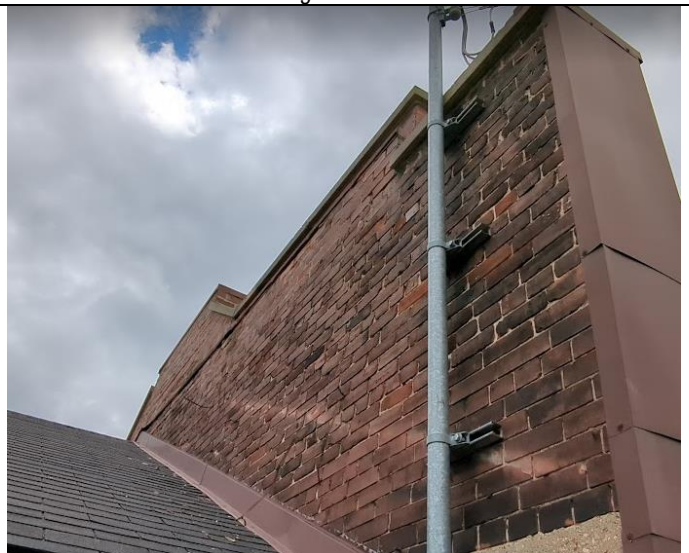
ELEMENT	OBSERVATIONS	COMMENTS	REF. PHOTOS
FAÇADE	– Minor brick and mortar joint cracking and deterioration	– Minor cracking and deterioration of bricks and mortar joints was found along the north and south face of the bricked structure.	6
	– Delaminated and deteriorated parging over bricks.	– Acoustical sounding revealed delamination of the parging covering a small portion of the West wall.	7
	– “Time Office” concrete medallion sign dowels exposed.	– The “Time Office” concrete sign above the main entrance had areas of delamination and spalling and what appeared to be exposed corroded dowels.	8
	– Deteriorated wood siding	– Deteriorated wood siding and peeling paint was noted along the east wooden (washroom) structure, along with areas covered with deteriorated plywood.	9
	– Deteriorated and concerning wall and foundation for exterior east washroom area	– Posts and other framing members appeared to be exposed within the east washroom structure. These structural members could deteriorate further due to weathering if left untreated or reinforced. Given the condition of the exterior siding, there were concerns with the overall integrity of the wall and foundation framing.	-

Photo 6: Cracking, deteriorated masonry and joints.

- Provide masonry repairs/replacements to the areas of deteriorated masonry and tuckpointing – **BUDGET \$60,000**
 - There is currently a small inventory of potentially matching bricks stored in the building. These bricks should be closely compared to existing and used to source more bricks as necessary for all required repairs.

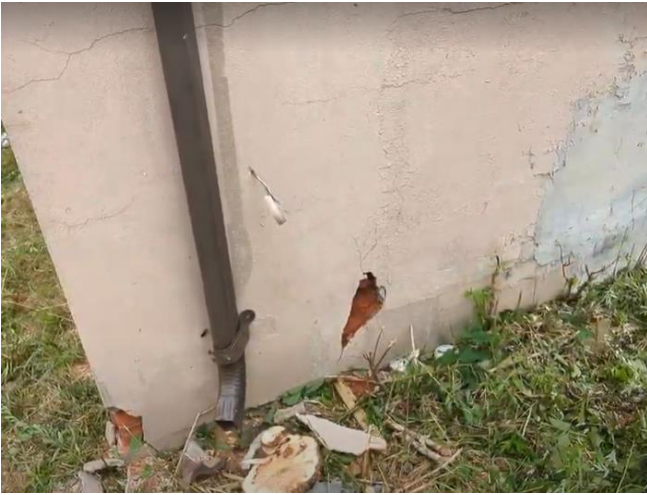
Photo 7: Delaminated parging and deteriorated brick behind.

- Special attention should be paid to the characteristics of the existing mortar and repair material sourced to match.
 - The areas covered in parging should be removed and bricks assessed and replaced as necessary. Full parging can be removed to expose the existing brick for aesthetics at the discretion of Brantford

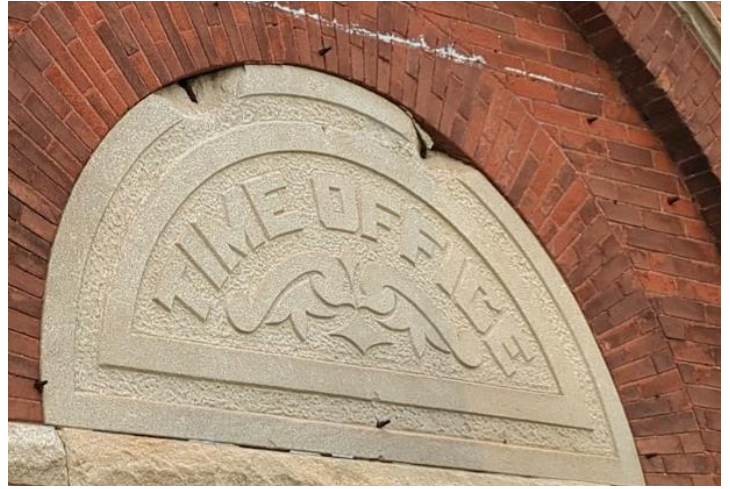
Photo 8: Deteriorated stone medallion and exposed dowels.

- Provide masonry repairs and/or interior support to the areas of deteriorated concrete medallion – **BUDGET \$15,000**
 - The steel dowels of the concrete medallion appear to have corroded, delaminated, and spalled the concrete at dowel locations. Given this, lateral support of the medallion is a concern. Typical concrete repairs to the medallion may not allow for adequate support, thus steel brackets on the back of the concrete are recommended. These will not be visible from the front of the building.

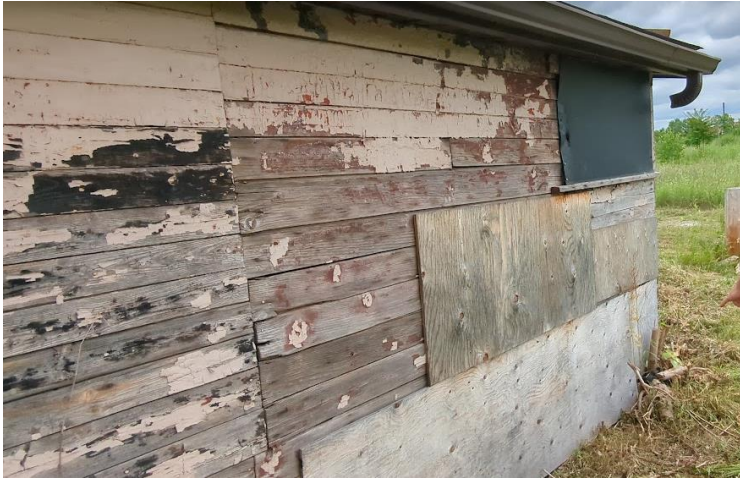
Photo 9: Deteriorated wood siding.

- Provide wood repairs and support to the areas of deteriorated wood siding and framing within the east wooden structure area of the building – **BUDGET \$50,000**

- Existing deteriorated wood posts and framing members should be reinforced and replaced as necessary.
 - Provide cleaning and selective demolition as required to expose structure and determine condition of members and repairs/reinforcing needed.

- Wood siding should be restored and repainted/stained/protected to match existing aesthetic, with minimal replacements as necessary.

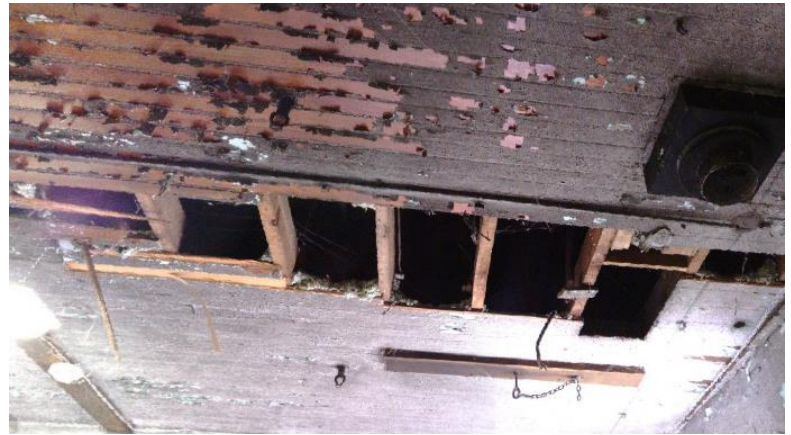
Photo 10: Exposed roof joists.

- Roof framing and joist repairs and reinforcing as necessary – **BUDGET \$10,000**
 - As noted above, only a small area of the roofing structure was exposed and reviewed. Given the age of the building and condition of the interior, further investigation is required to determine the full extent of any required repairs and reinforcements, thus the budget above should be considered a placeholder until further investigation. However, based on our review, no deterioration was noted.

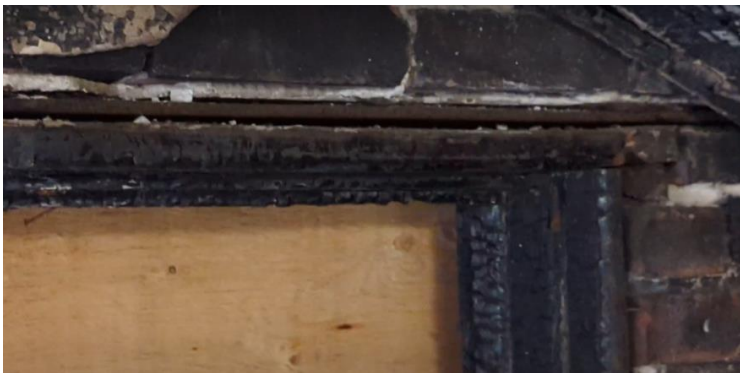
Photo 11: Steel lintel.

- Sand, stain, and apply protective finish to exterior window and door frames. Replace to match any portions of wood that are rotten and have lost structural integrity.
- Replace existing plywood with black painted new marine-grade plywood as per Property Standards By-law (Article 29, Section 4)
- Repair or replace existing concrete and steel lintels as necessary. These items should be further investigated and reviewed during construction.

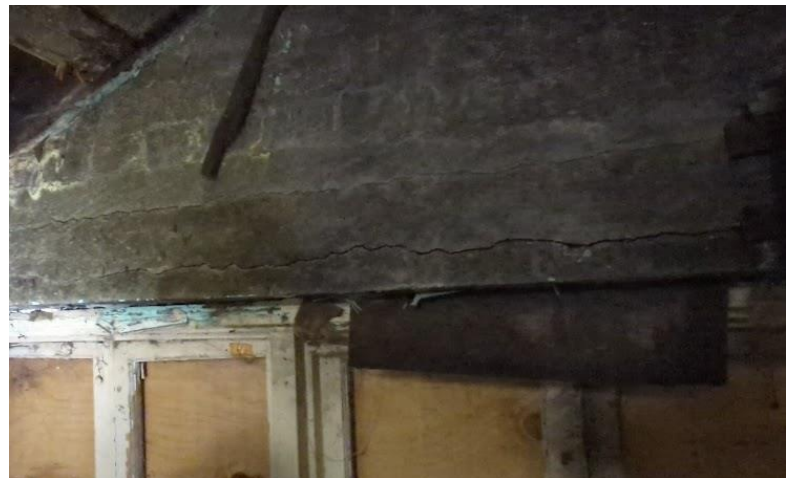
Photo 12: Deterioration of concrete lintel.

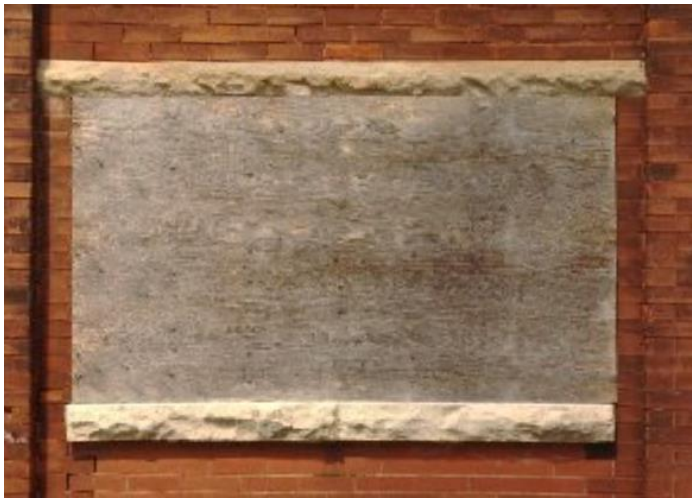
Photo 13: Boarded windows.

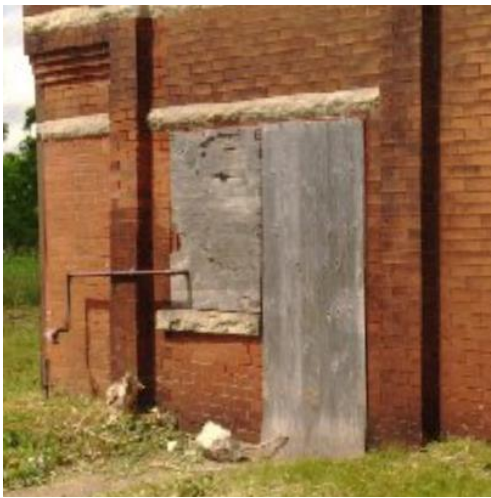
ROOF	– New roof shingles	– The shingles appeared to have been recently replaced as they appear new with no major concerns.	-
	– Exposed ceiling joists	– An area of missing ceiling finish revealed the roof joists above.	10
WINDOWS AND DOORS	– Exposed steel lintel.	– The exposed lintel was above a window within the West portion of the building, as observed from the interior. It should also be noted that cracking of the masonry was noted beneath a bearing location.	11
	– Deteriorated concrete lintel	– A deteriorated concrete lintel was noted within the East portion of the building, as observed from the interior.	12
	– Boarded, sealed windows	– Window openings were boarded, and the majority of windows not exposed for review, however the visible portions did indicate wear and deterioration.	13
	– Boarded, sealed entrance door	– The entrance door opening was boarded, and the majority of the door not exposed for review, however the visible portions did indicate wear and deterioration.	14

Photo 14: Boarded door.

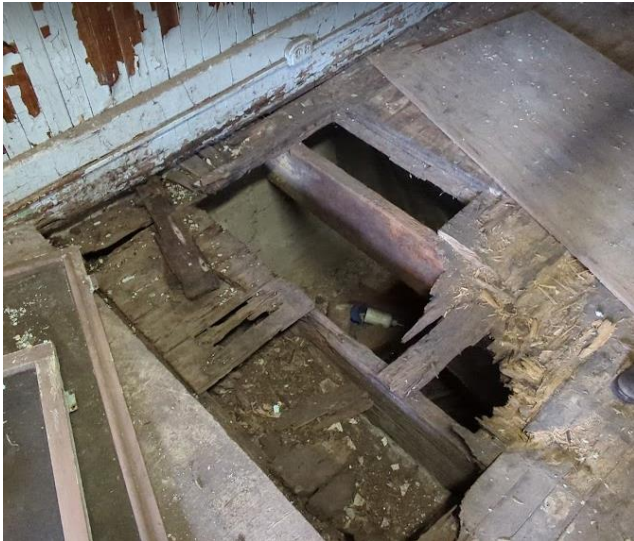
Photo 15: Deteriorated wood flooring.

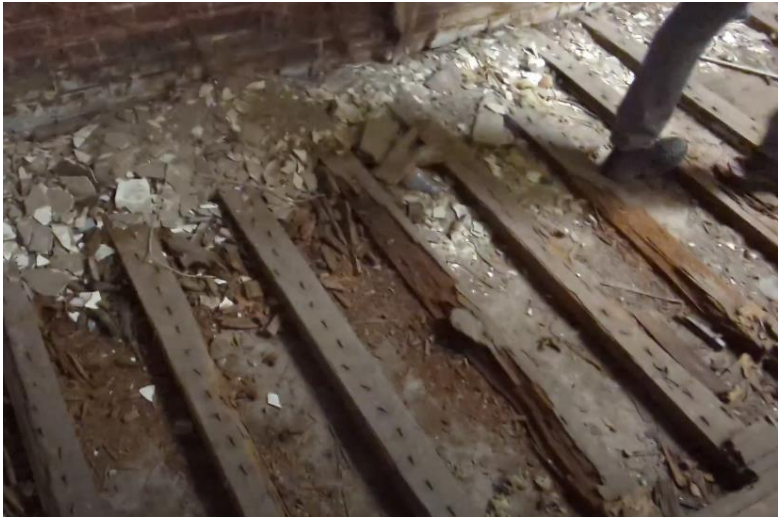
INTERIOR FLOORING	– Deteriorated flooring and exposed joists	– The plywood atop wooden floor joists were displaced, deteriorated and missing in areas, exposing the wood floor joists below. – The interior flooring within the central portion of the building appeared to require replacement and repairs to several members including joists and various structural members.	15
	– Deteriorated wood furring	– The wood furring strips along with the covering plywood within the West portion of the building appeared to be deteriorated and in need of replacement	16

Photo 16: Deteriorated wood flooring.

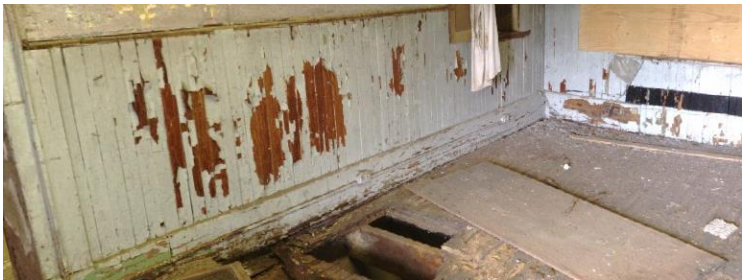
Photo 17: Deteriorated interior finishes.
