# CITY OF BRANTFORD TRAIL SAFETY AUDIT

# TRAIL SAFETY AUDIT DRAFT REPORT

CITY OF BRANTFORD

PROJECT NO.: 221-05994-00. DATE: SEPTEMBER 20, 2022

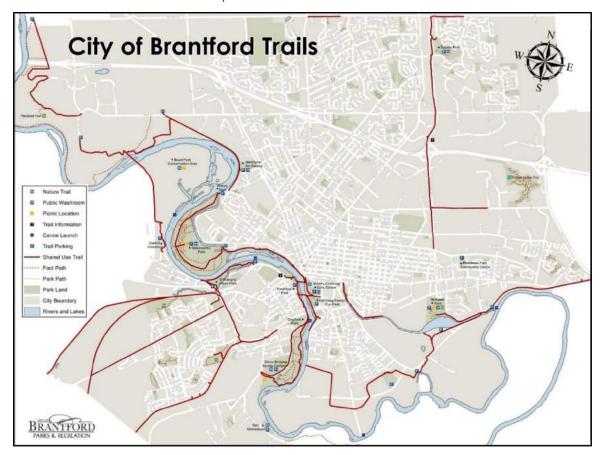
**Figure 1 City of Brantford Trails Map**

The City of Brantford is completing a safety audit of the City's trail system. The project focuses on multi-use paths and off-road trails within the City (Solid red Shared Use Trail per **Figure 1 2019 City of Brantford Trails Map**). Roughly 15km of multi-use paths and 40km of off-road trails have been included in the audit. Additionally, one foot path through Royal Oak Park was for identified for review. The trail system includes a section of the Trans Canada Trail, and connects Brantford to the communities of Port Dover, Hamilton and Paris.

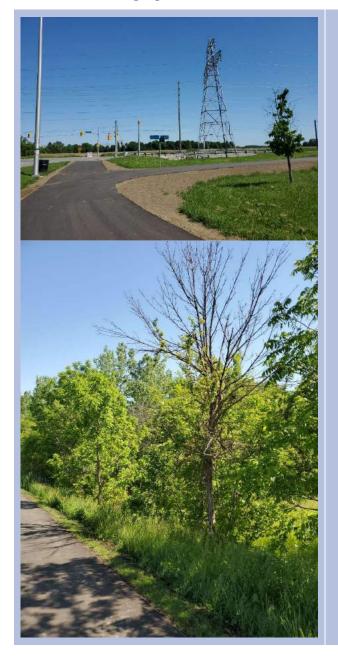
Wayne Gretzky Parkway Trail from Powerline Road to Dunsdon Street (Appendix A - Audit Reference Map Figure 1a)

- Newly paved. Asphalt in very good condition
- Lacks line paint features per OTM Book 18
- Numerous hazard trees present.
- Sloped blind corner may present user conflicts.

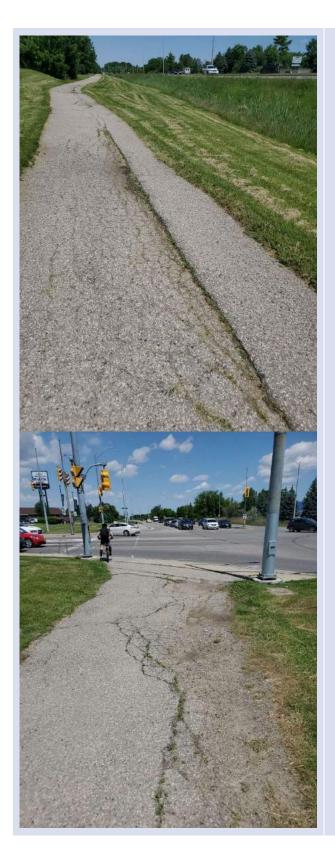
Wayne Gretzky Parkway Trail from Dunsdon Street to Grey Street (Appendix A - Audit Reference Map Figure 1a)

- Multiple locations where Asphalt in poor condition
- Lacks line paint features per OTM Book 18
- Intersections not designed per OTM Book 18

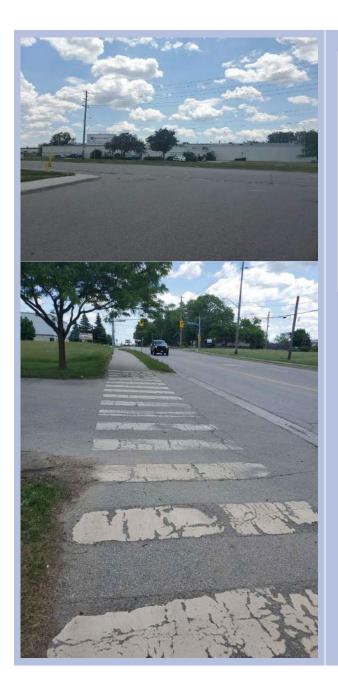
Henry Street Trail from Wayne Gretzky Parkway to Middleton Street (Appendix A - Audit Reference Map Figure 1a)

- Multiple locations where Asphalt in poor condition
- Lacks line paint features per OTM Book 18
- Intersections not designed per OTM Book 18
- Lacks AODA features

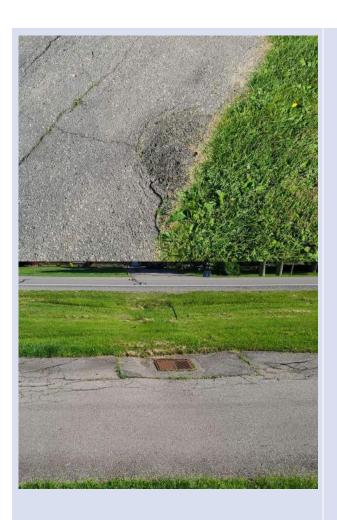
Powerline Trail from King George Road past Francis Street (Appendix A - Audit Reference Map Figure 1a)

- Multiple locations where Asphalt in poor condition
- Lacks line paint features per OTM Book 18
- Road crossings and signs designed per OTM Book 18

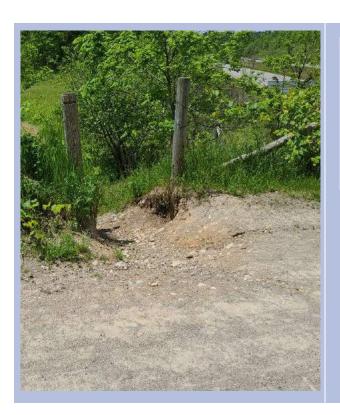
SC Johnson Trail from Powerline Road to Kraemer's Way (Appendix A - Audit Reference Map Figure 1b)

- Limestone surface in overall good condition
- Some minor erosion to trail surface

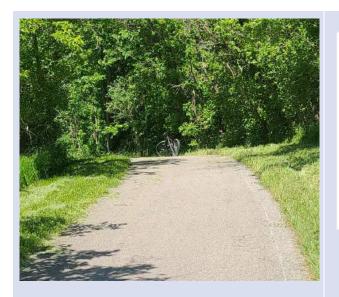
# SC Johnson Trail from Oak Park Rd to Hardy Rd (Appendix A - Audit Reference Map Figure 1b)

- Surface in overall good condition
- Numerous blind corners present
- Some excessive longitudinal slopes
- Lacks line paint features per OTM Book 18

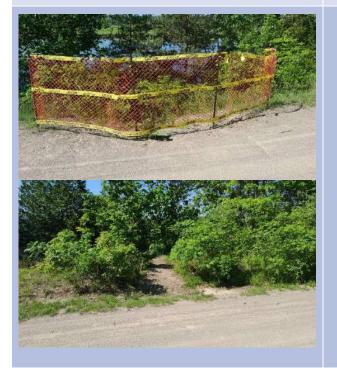
# SC Johnson Trail from Hardy Rd to Wilkes Dam (Appendix A - Audit Reference Map Figure 1b)

- Surface in overall good condition
- Numerous areas of erosion at the edge of limestone trail into adjacent slope
- Some CPTED concerns with understory encroaching on tertiary trail entrances.

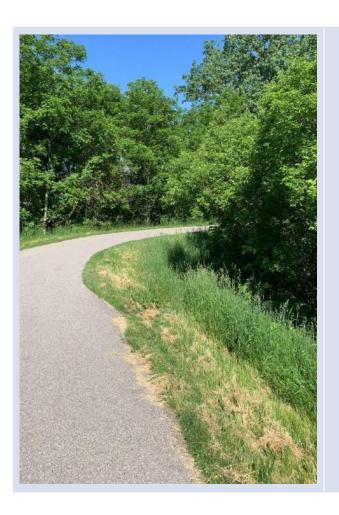
SC Johnson Trail from Wilkes Dam to Yorkshire Street (Appendix A - Audit Reference Map Figure 1c)

- Asphalt surface in overall good condition
- Lacks line paint features per OTM Book 18

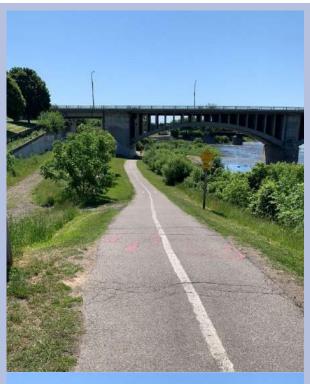
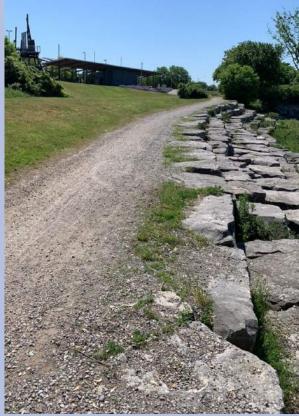
SC Johnson Trail from Yorkshire Stree to Brant's Crossing (Appendix A - Audi Reference Map Figure 1c)

- Asphalt surface in poor condition
- Narrow trail, loose surfaces, excessive longitudinal slopes and blind corners
- Detailed redesign occurring as part of separate project

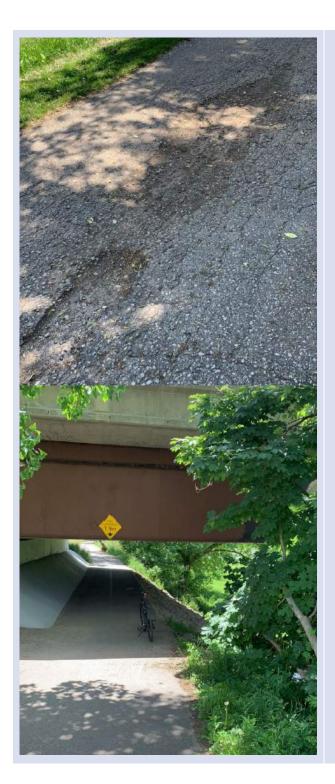
# SC Johnson Trail from Brant's Crossing to River Rd (Appendix A - Audit Reference Map Figure 1c)

- Multiple locations where Asphalt in poor condition
- Lacks line paint features per OTM Book 18
- One steep adjacent side slope

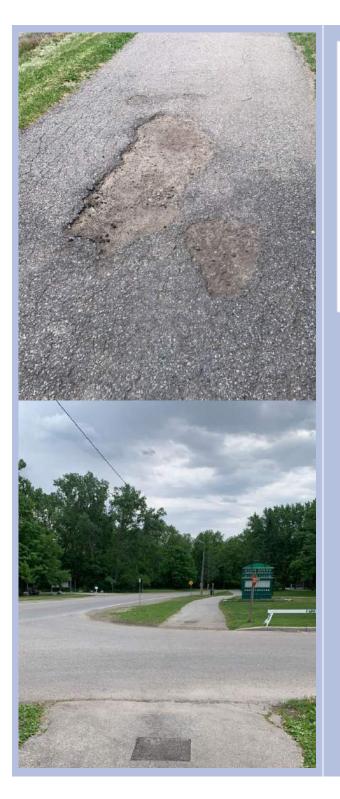
Fordview Trail along Gilkinson St from Colborne St W to Mt Pleasant Dr (Appendix A - Audit Reference Map Figure 1c)

- Multiple locations where Asphalt in poor condition
- Lacks line paint features per OTM Book 18
- Some excessive longitudinal slopes
- Intersections not designed per OTM Book 18
- Lacks AODA features

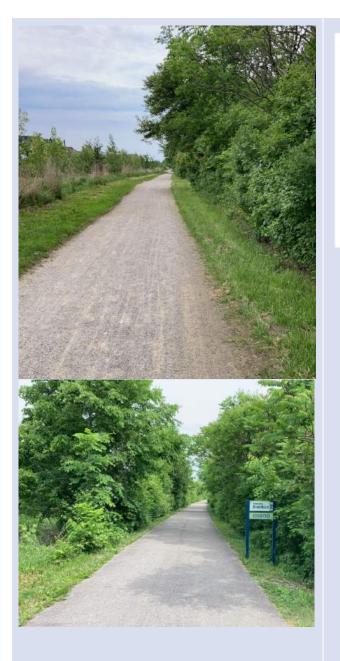
CN Rail Trail and TH&B Trail from Hwy 7 to Veteran's Memorial Pkwy, Shellard Lane MUT, LE&N Trail from Ellis Ave to Veteran's Memorial Pkwy (Appendix A - Audit Reference Map Figure 1c)

- Limited safety issues. Trails generally in good condition.
- Asphalt sections lack line paint features per OTM Book 18

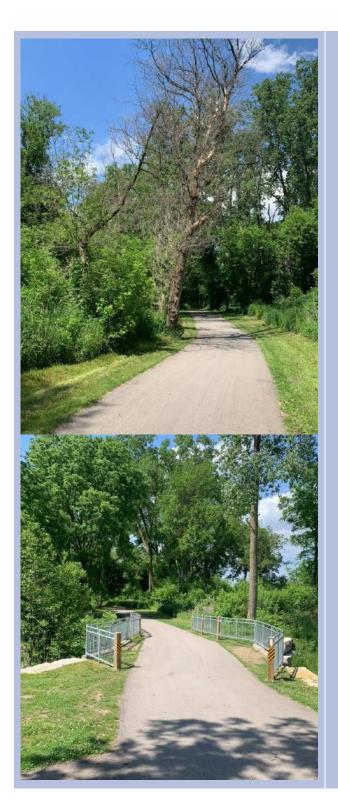
Gilkinson Trail from Mt Pleasant Dr to Gilkinson St (Gilkinson Flats) (Appendix A - Audit Reference Map Figure 1c)

- Asphalt overall in good condition
- Lacks line paint features per OTM Book 18
- Some sharp turns
- One fall risk
- Intersections not designed per OTM Book 18
- Numerous Hazard Trees

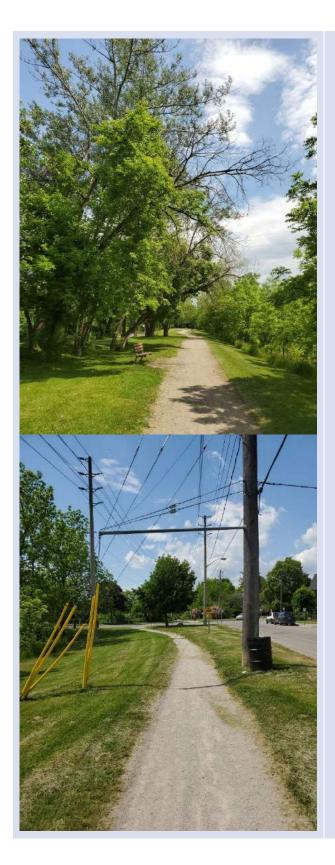
# Shallow Creek Trail from East Ave to Drummond St (Appendix A - Audit Reference Map Figure 1d)

- Some portions of limestone path are narrowing
- Numerous Hazard Trees

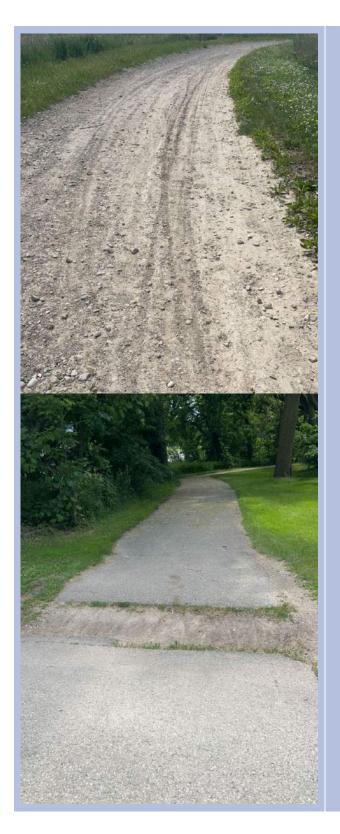
Hamilton-Brantford Rail Trail from River Rd to Beach Rd (Appendix A - Audit Reference Map Figure 1d)

- Major portions of limestone trail have loose gravel surfaces
- Minor sections of asphalt path degrading
- Some ponding/saturation
- One cut section of asphalt path

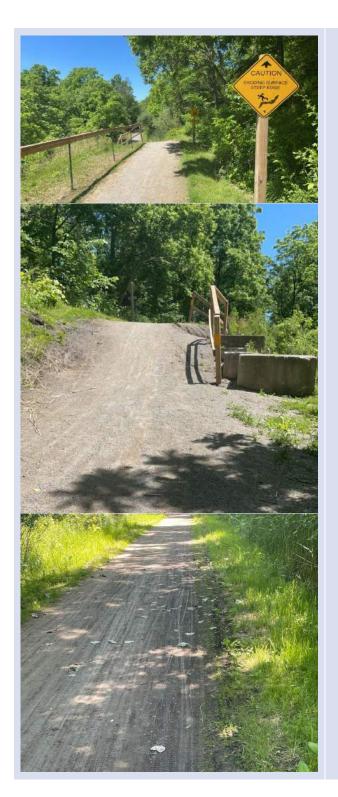
# Hamilton-Brantford Rail Trail from Beach Rd to Hwy 18 (Appendix A -Audit Reference Map Figure 1d)

- One section with major excessive longitudinal and adjacent side slope.
- Section from Colborne St W to Hwy 18 highly saturated.

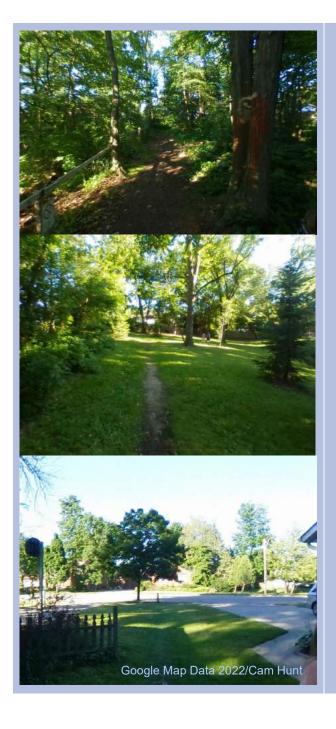
Royal Oak Park Trail connecting Memorial Dr to Royal Oak Dr (Appendix A - Audit Reference Map Figure 1a)

> Roughly 200 metres of narrow inaccessible foot path through Royal Oak Park.

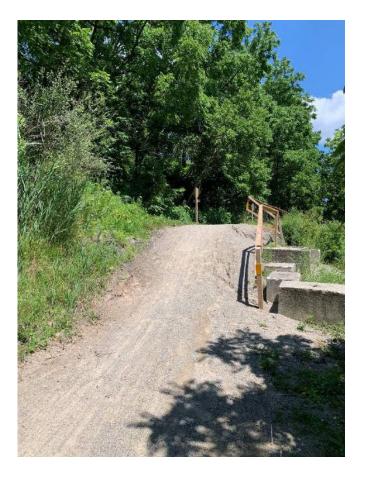
Figure 4. A steep limestone trail showing signs of erosion on the Hamilton-Brantford Rail Trail

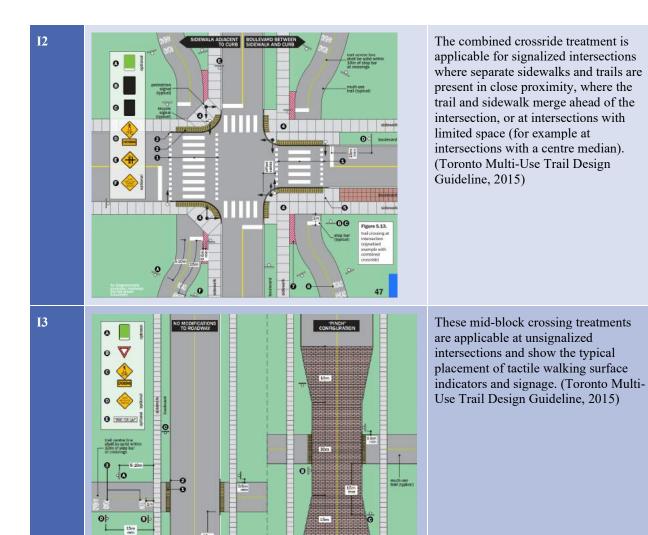
Tactile walking surface indicator and flush curb, match width of trail (typical)

Curb transition (typical) 1.2 metres

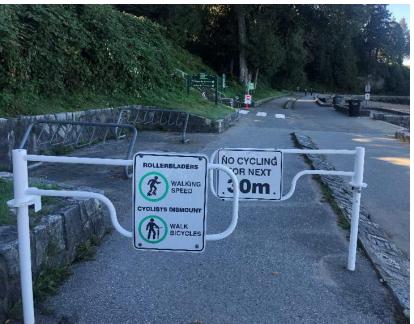
Figure 10: A gateway leading to a prohibitive cycling section of the Stanley Park Seawall in Vancouver, BC.

The City of Vancouver has several highly frequented pedestrian areas along the Stanley Park Seawall that require cyclists to fully dismount to reduce pedestrian-bicycle conflicts. The use of a maze gate (Figure 10) for restricting access is sometimes used, but should not be implemented unless all other avenues have been

exhausted. These features can reduce the accessibility of a trail, and also reduce access for people on non-standard bicycles, people pulling trailers, people riding cargo bikes or cyclists with disabilities who are unable to easily dismount their bike, In Vancouver, where these features have been installed, prior to the approach of each of these zones cyclists are provided with an adequate warning signage ahead of the gate and the Seawall has a speed limit of 15km/h in those

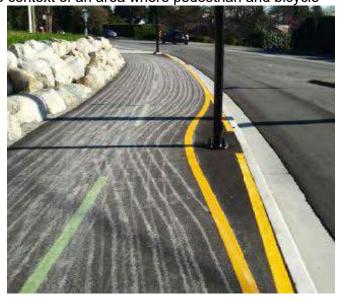
Figure 12: A hazard stripe painted around a lamppost in North Vancouver, BC.

Where non-user conflicts may exist such as lamp posts, hydro poles, bollards, etc. hazard striping pavement markings can be used. These pavement markings can guide users around a potentially hazardous object along a multi-use pathway, guiding users to avoid colliding with the object (**Figure 12**). This pavement marking can also signal to other users that the trail is narrowing in the area, so they should exercise caution when passing other users.

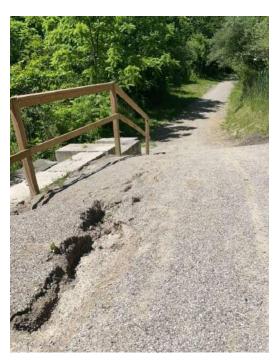
Figure 18 – Trail erosion in need of maintenance

Reducing maintenance through strategic infrastructure investments, including trail realignment, surface treatment and use of structures should be considered for areas of reoccurring maintenance issues.
