97 Wellington Street
Brantford
(GBCA Project No: 24007)

Heritage Impact Assessment

1st issue: May 17, 2024
2nd issue: December 5, 2024

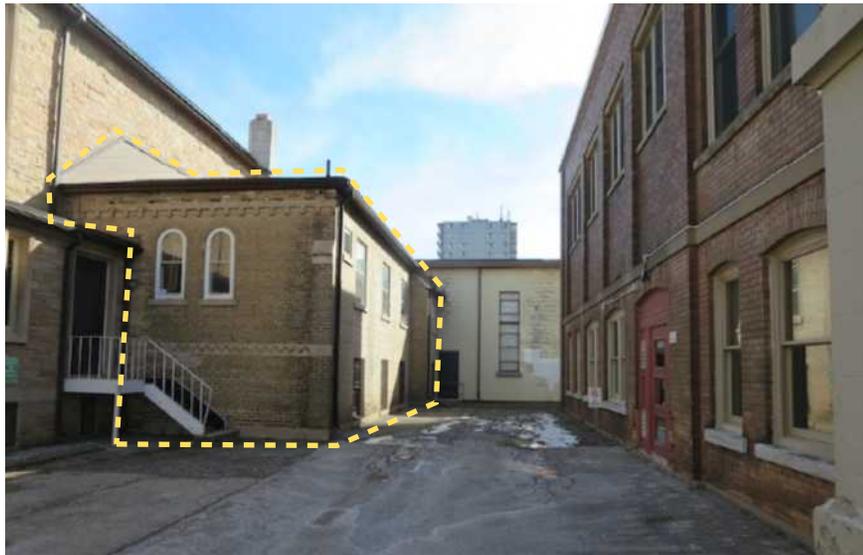
View, looking east, showing the 1948 addition (highlighted in yellow) connecting the 1961 church (on the left) and the 1956 addition (visible in the background).

The 1948 addition is a two-storey brick structure whose purpose was to contain the church parlors on the ground floor and a vestry, committee rooms and washrooms on the second floor. This 1940s structure also contains, in the basement, the boiler room which was added to provide better heating to the 1860s church.

Some attempt was made to coordinate the exterior of the 1948 addition with the 1865 Gothic-Revival Church. Built with a buff brick exterior, the street facing (west) elevation employed decorative brick accents and a corner buttress with coping stone, along with round-headed windows to light the Vestry office within. The remainder of the building is typical of 1940s architecture with simple rectangular openings and minimal ornamentation.

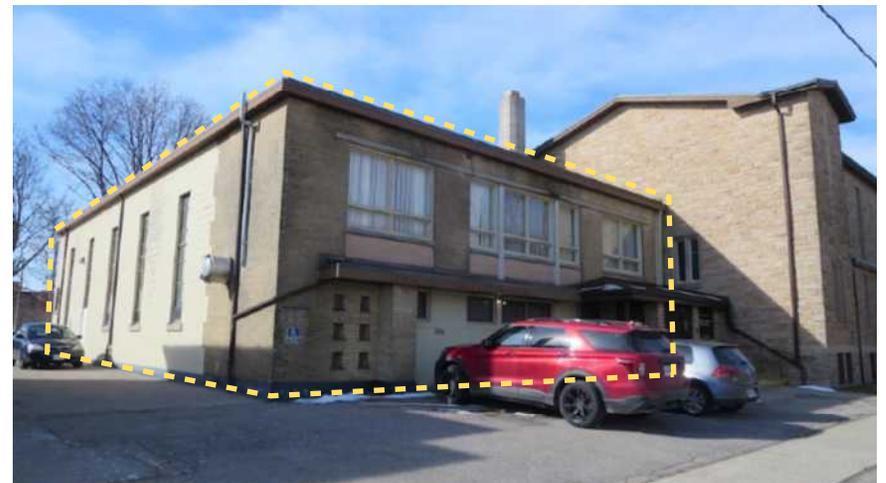
Rear view, looking southwest, showing the 1956 addition (highlighted in yellow).

The 1956 School Addition is a two-storey concrete block and brick structure with flat roof. The north façade (facing Wellington Street) uses the same buff brick that was used on the 1948 addition. Large wood frame windows on the second-floor light the Sunday school rooms within, while the first floor contains the kitchen facilities.

The remainder of the building is painted concrete block. The east and west elevations have long narrow window openings corresponding with the two-storey space within. The building primarily contains the double-height Sunday School hall which has tile floor and ceiling and a stage at one end. A mezzanine on the north end of the hall (with the Sunday School classrooms) sits above the church kitchen.

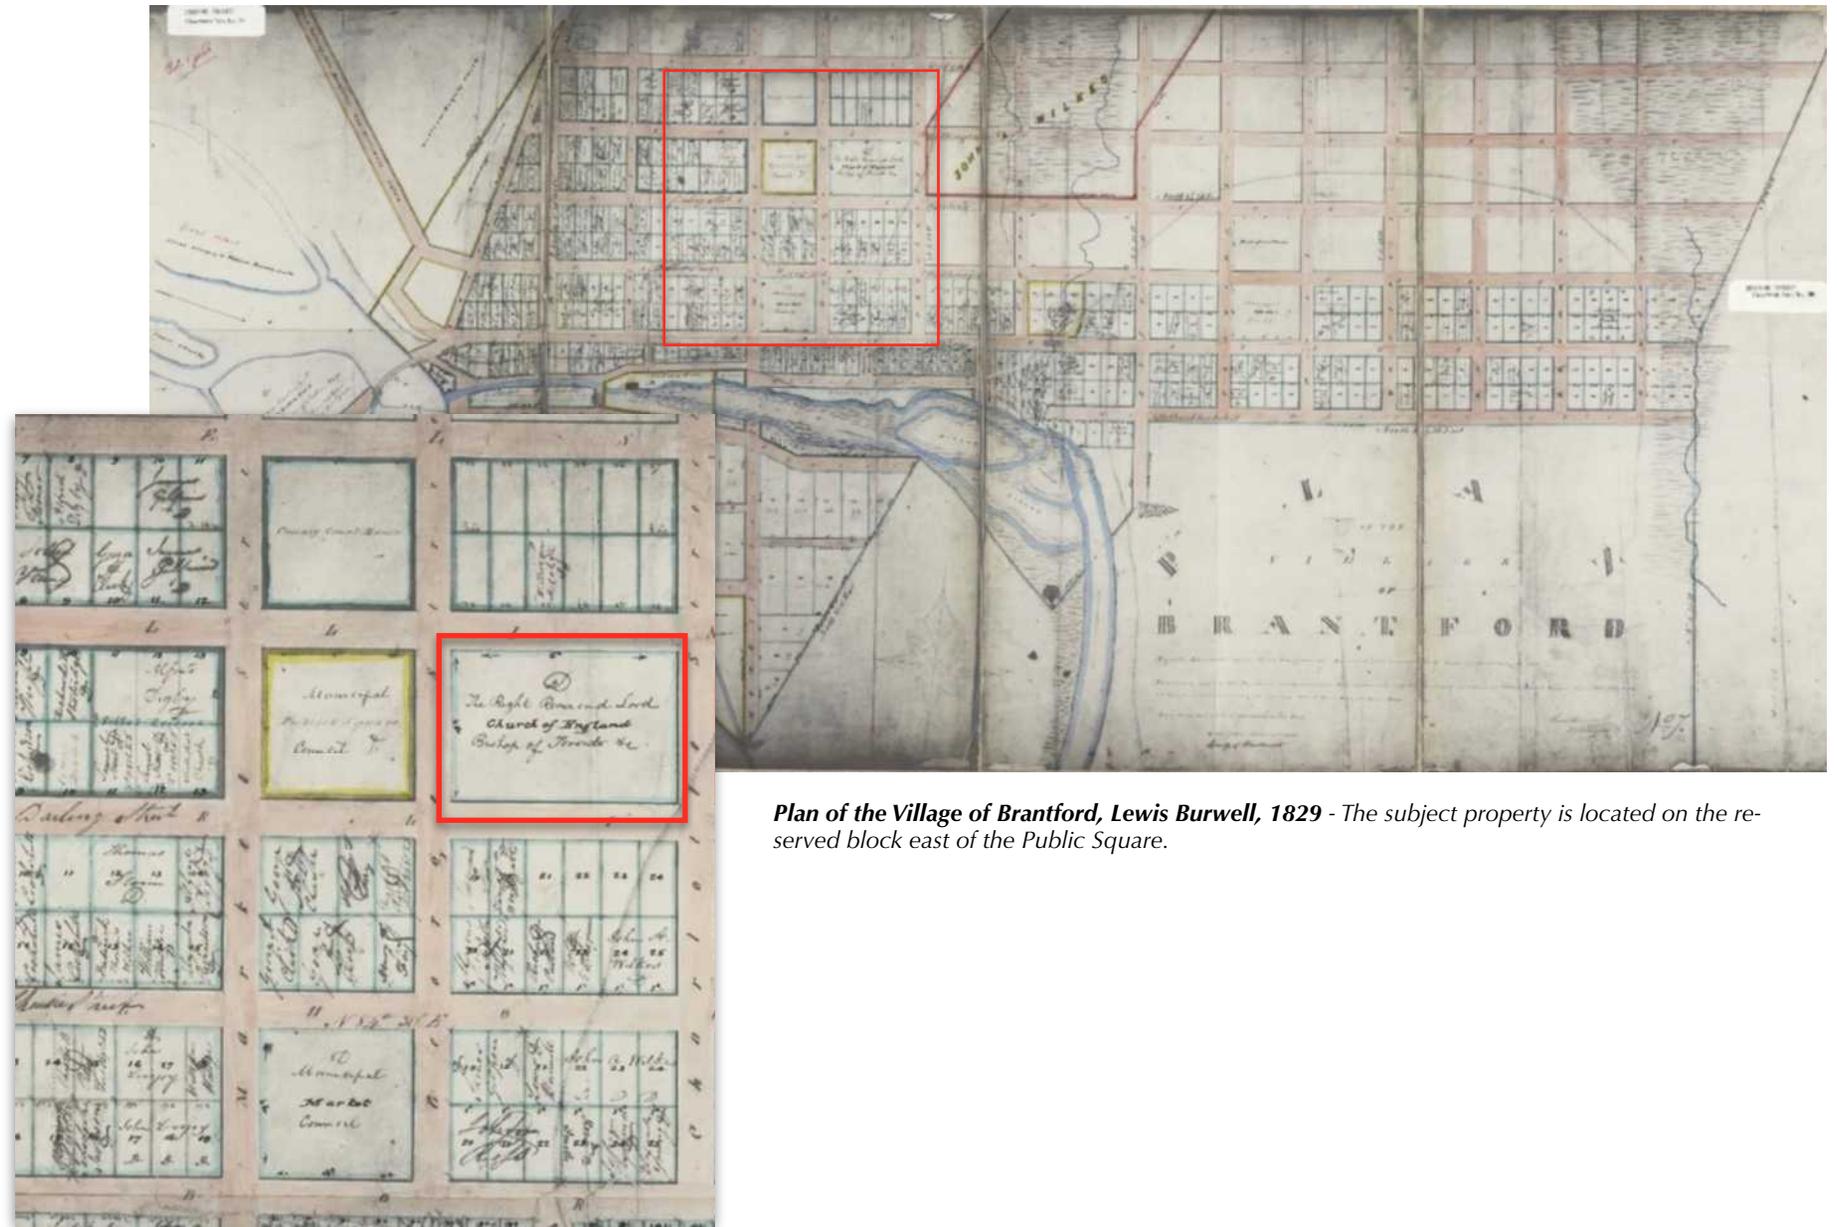
Plan of the Village of Brantford, Lewis Burwell, 1829 - The subject property is located on the reserved block east of the Public Square.

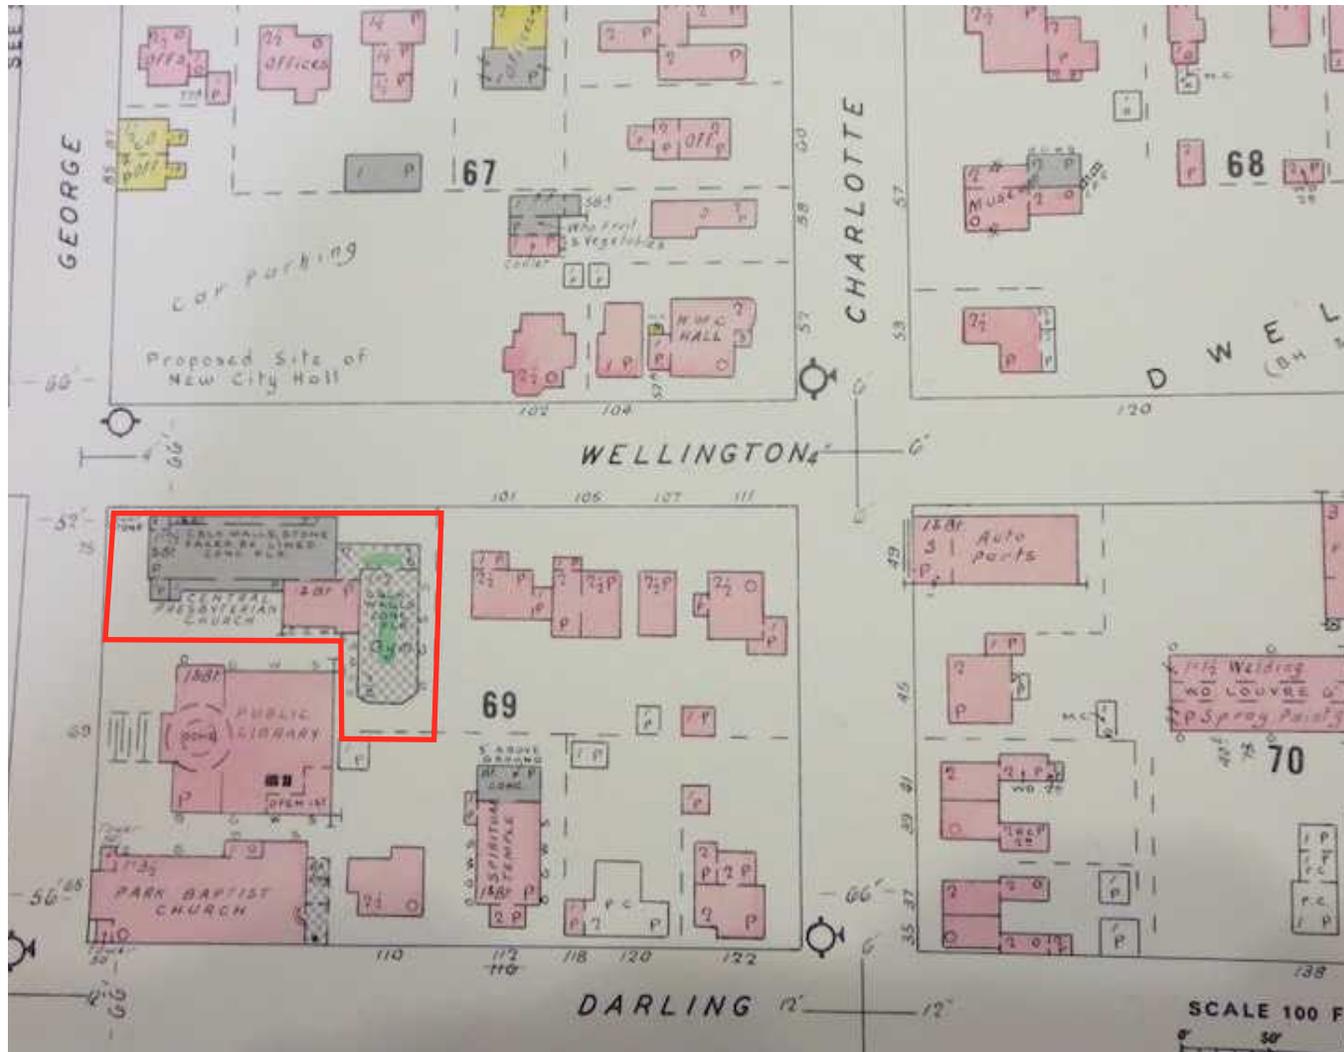
Fire Insurance Plan of the City of Brantford, Ontario, Underwriters' Survey Bureau, 1965 - The Fire Insurance Plan shows the extent of the 1948 rear addition to the 1865 church (denoted in red as brick construction); the 1956 Sunday School addition (denoted in grey hatches as concrete block construction); and the new 1960-1961 church building (denoted in grey as concrete and stone construction).

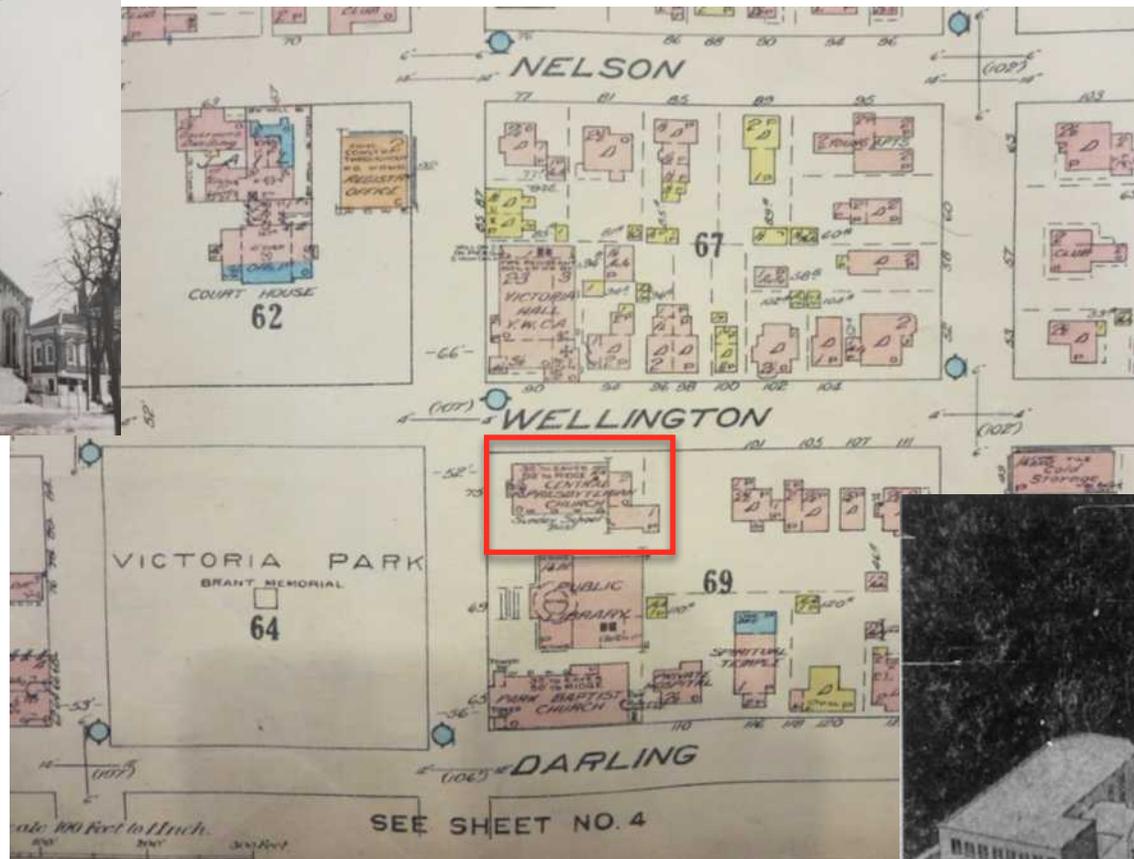
Fire Insurance Plan of the City of Brantford, Ontario, Underwriters' Survey Bureau, 1950 - The Fire Insurance Plan shows the extent of the 1948 rear addition to the 1865 church (pictured inset above left). Within a few years of the construction of that addition, the Sunday School addition was constructed - the image right is a model of the proposed addition from 1956.

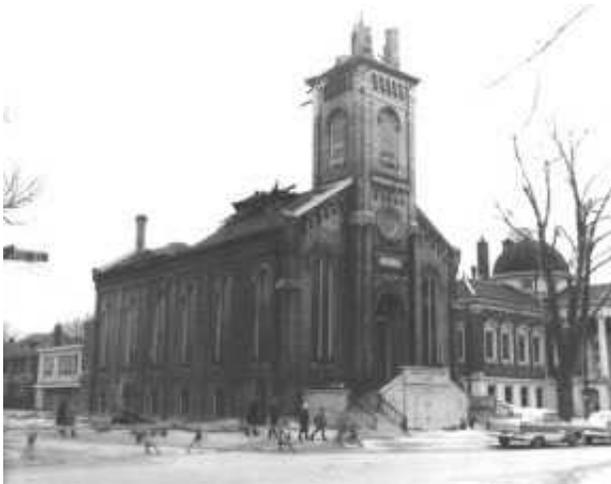
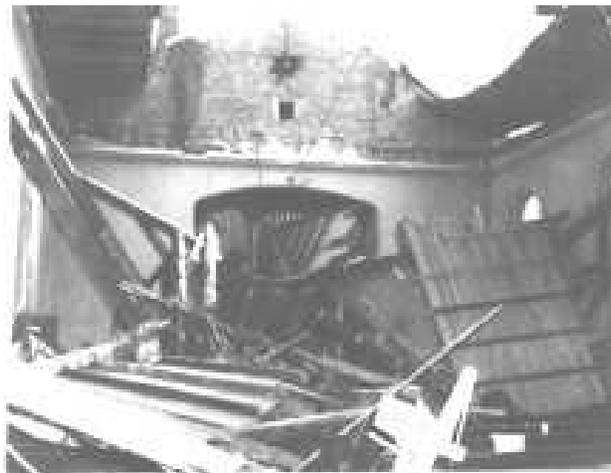
Exterior and Interior of the Central Presbyterian Church after damage due to the wind storm, 1959

On 15 March 1959, the sanctuary of the 1865 church was seriously damaged from hurricane force winds that ripped through the city causing widespread damage. The 165-foot-tall spire (at the time, Brantford’s tallest structure) crashed through the roof into the empty church – luckily the evening service had been cancelled due to the severe storm. Damage to the church was confined to the “older part” – the more recent 1948 and 1956 additions were not damaged – but the damage was so bad that the entire 1865 church ultimately had to be demolished.

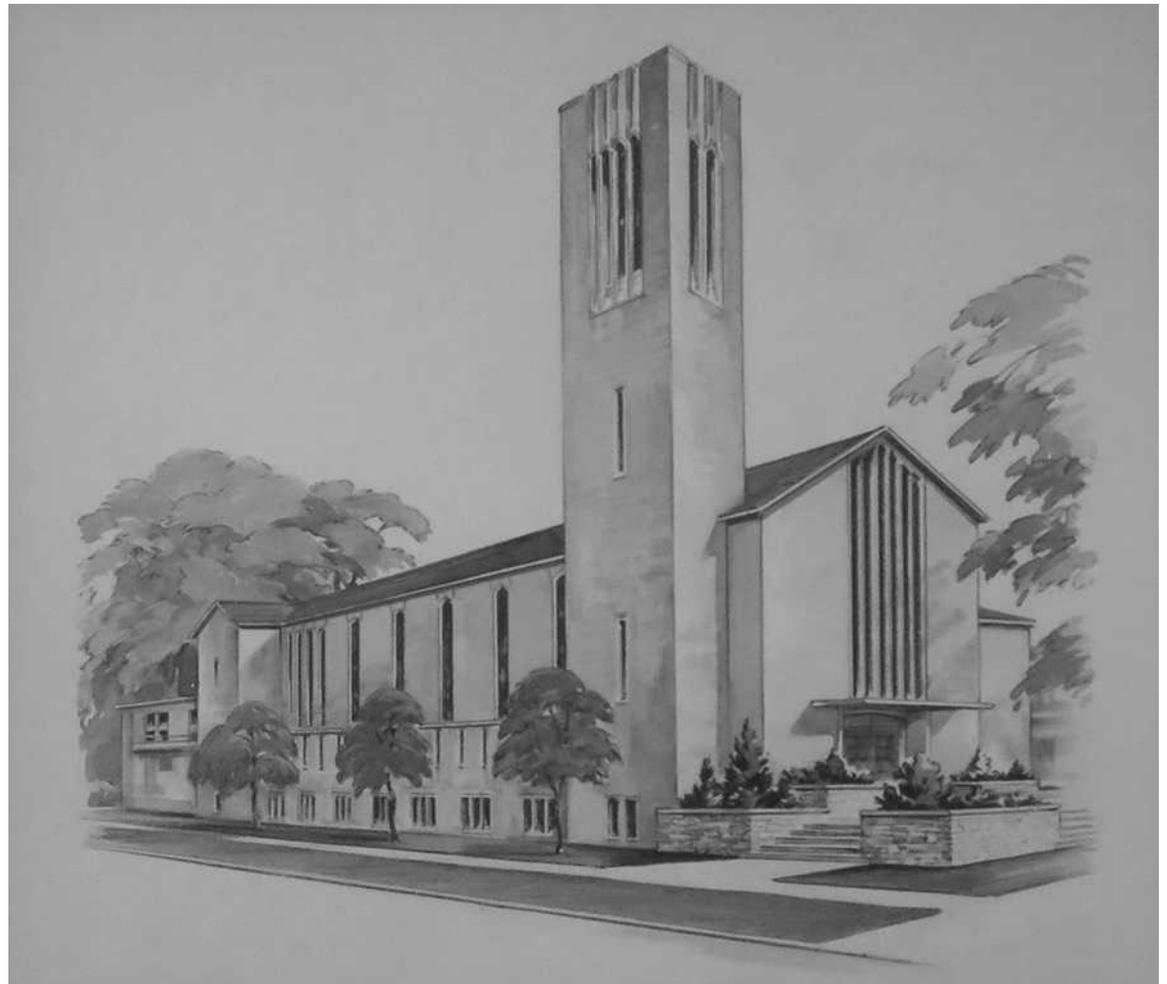
Design for the new Central Presbyterian Church by Bruce Brown and Brisley, 1960-1961

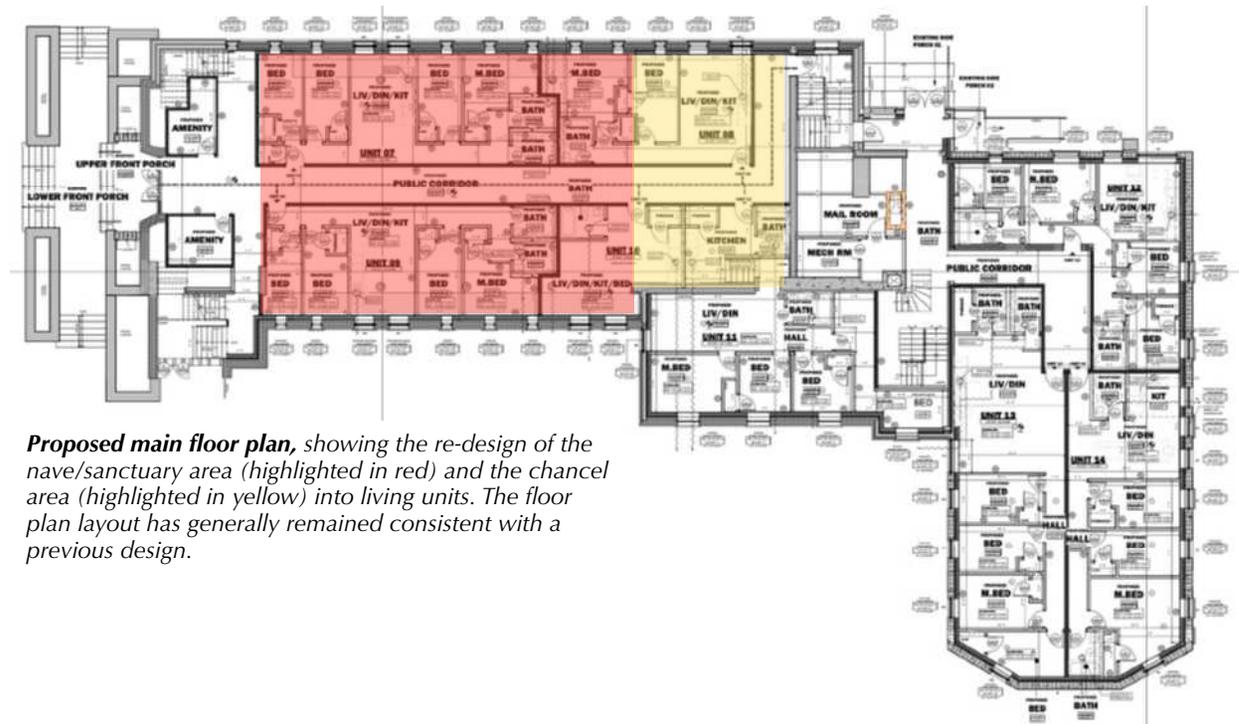
Proposed main floor plan, showing the re-design of the nave/sanctuary area (highlighted in red) and the chancel area (highlighted in yellow) into living units. The floor plan layout has generally remained consistent with a previous design.

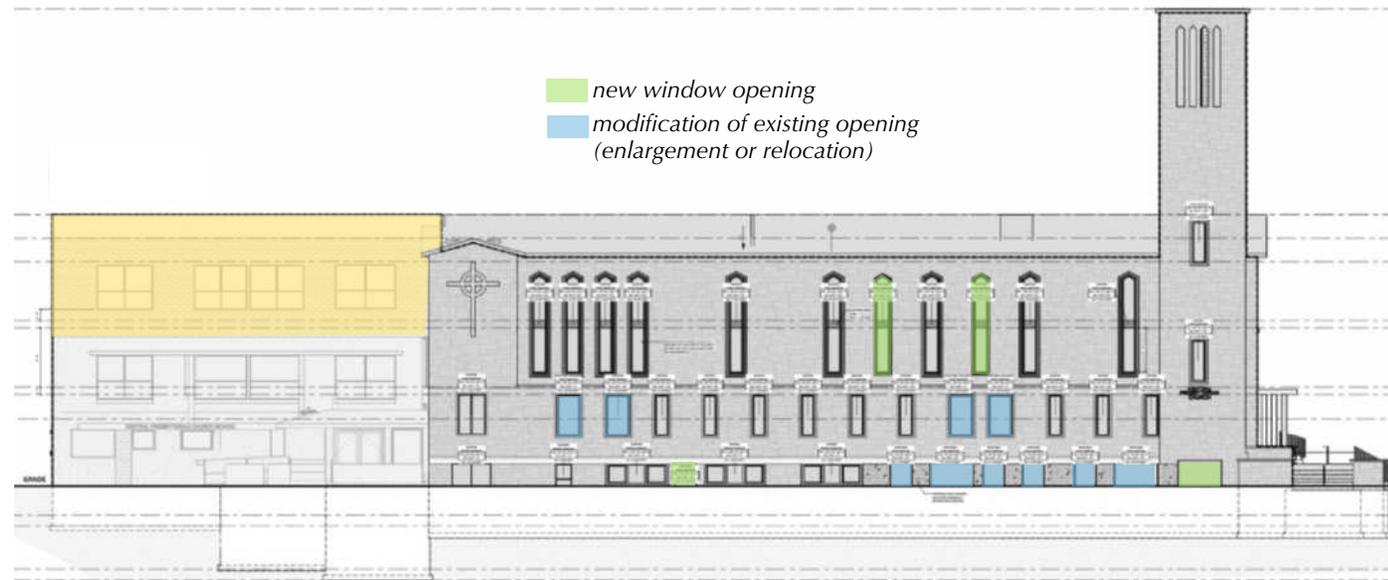
Proposed north (Wellington Street) elevation, showing the added third floor (highlighted in yellow) to the rear of the church. Of note is the addition of window openings (highlighted in green) or modifications to existing window openings (highlighted in blue) along the north wall of the main church building.

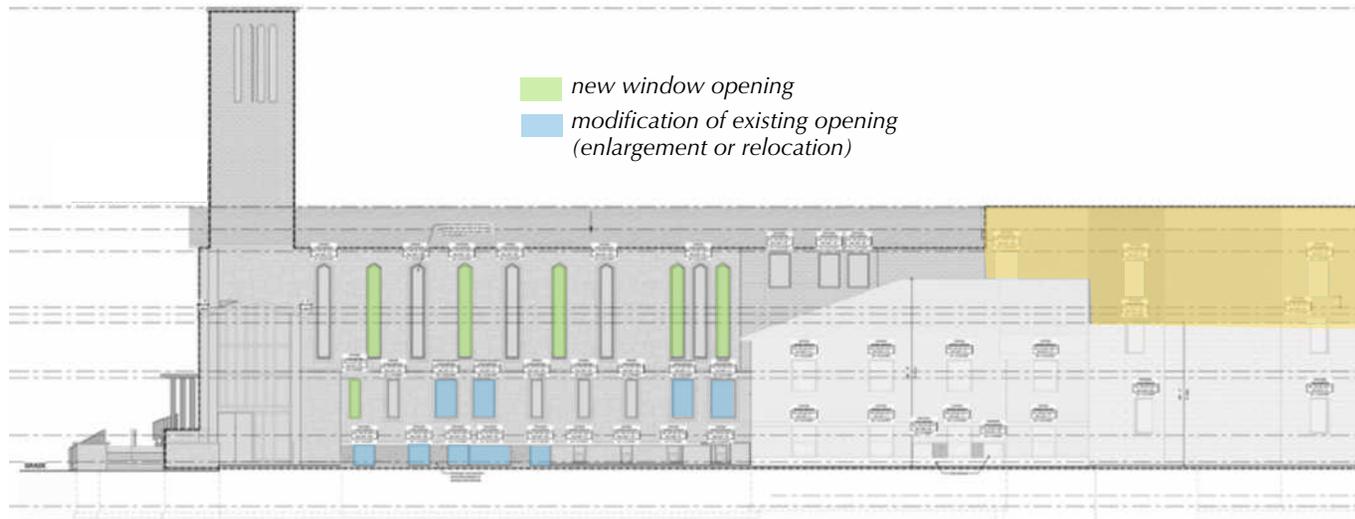
Proposed south elevation showing the added third floor (highlighted in yellow) to the rear of the church. Of note is the addition of window openings (highlighted in green) or modifications to existing window openings (highlighted in blue) along the north wall of the main church building.

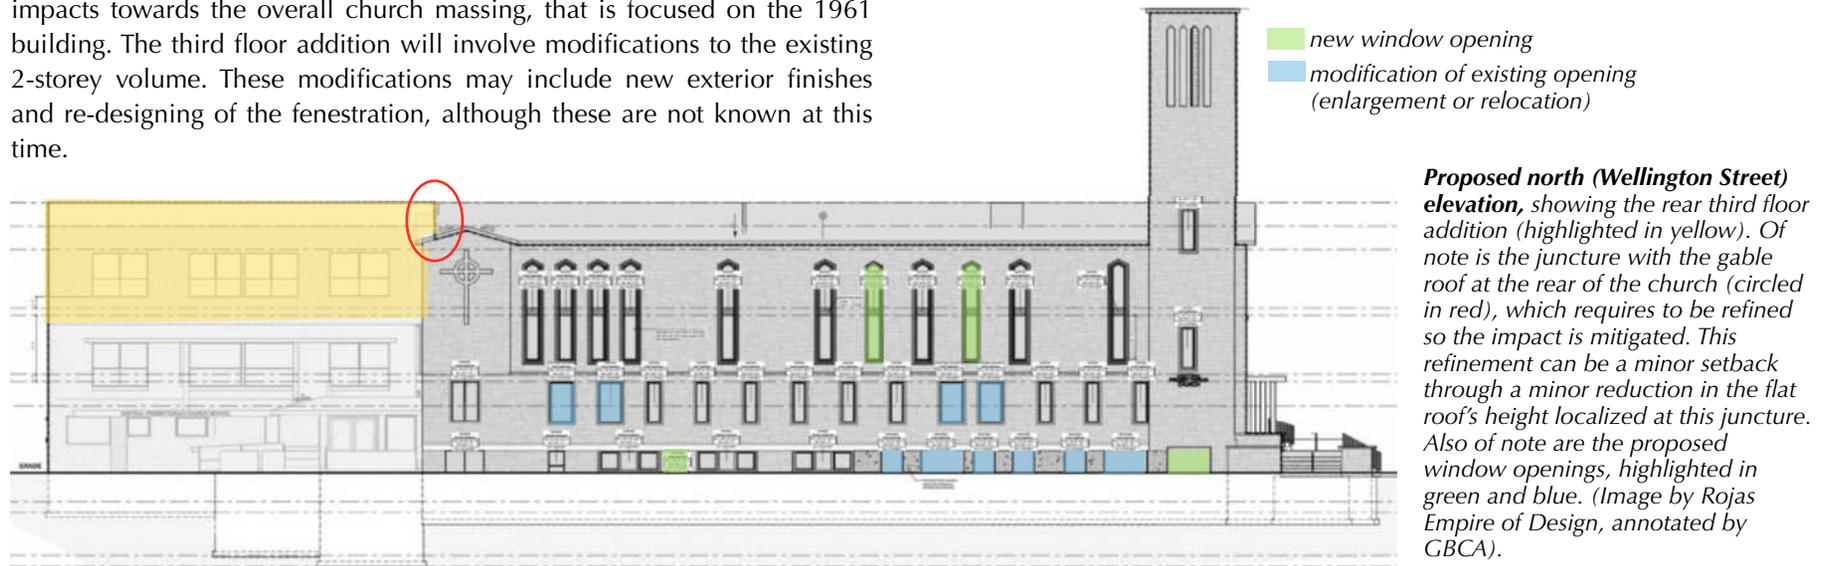
It is noted that the third floor addition may impact the way in which the building connects with the gable eaves of the rear of the original church. The third floor addition, while lower than the ridge of the church's roof, will interrupt the gable eave detailing.

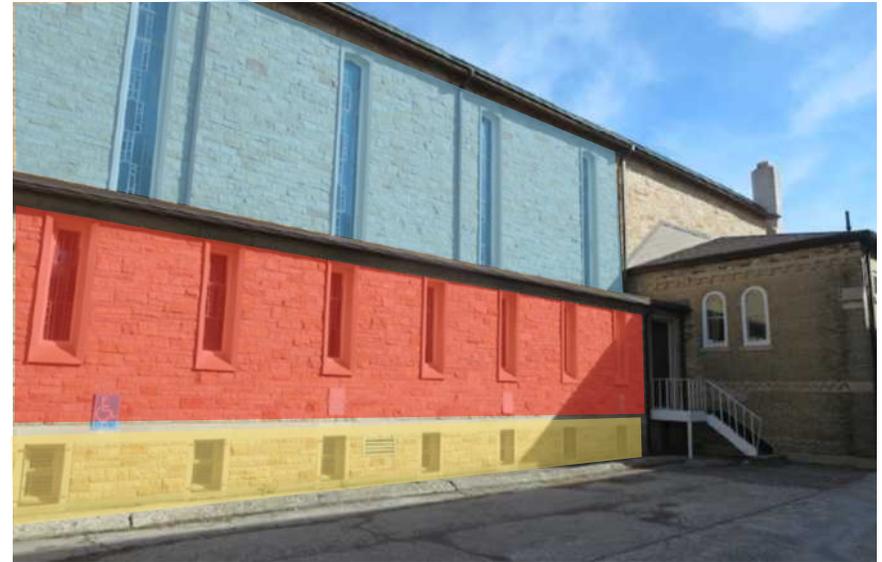
Overall view of the south elevation. Note the basement (highlighted in yellow) has few and smaller openings. Additional openings will be required to increase natural light into units, as well as new openings along the side aisles (highlighted in red) and nave (highlighted in blue).

An impact noted earlier as a result of the new window openings along the side aisles may be the alteration to the mosaic inset plaques. The larger width of the openings may damage these mosaic plaques. The size of the windows on the exterior will therefore need to consider these plaques to mitigate any potential damage on the inside.

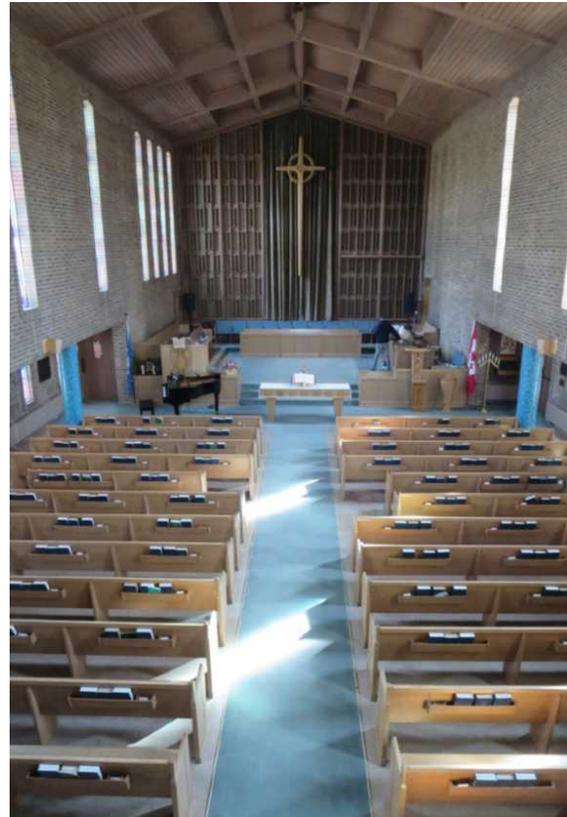
Overall interior view towards the chancel. To rehabilitate the space, the wood pews, wood screen at the end of the chancel and ecclesiastical furniture will need to be removed.

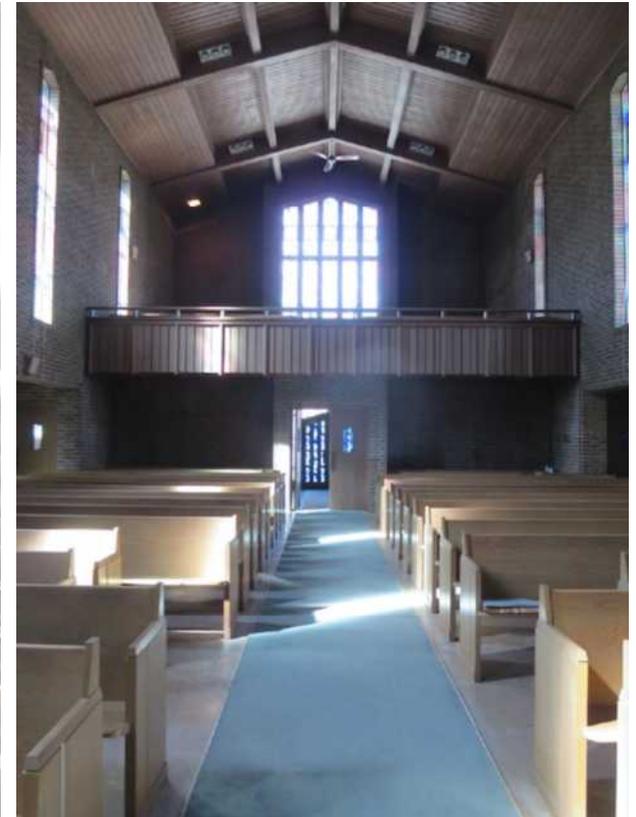
Overall interior view towards the narthex. To rehabilitate the space, the wood pews and wood balcony railing will need to be removed.

Finishes such as brick masonry and mosaic-tiling can remain without the need for their removal. Exploratory openings will be required to determine structural requirements. Mitigation strategies to guide conservation as the design progresses into future stages are discussed in the next section of this HIA.

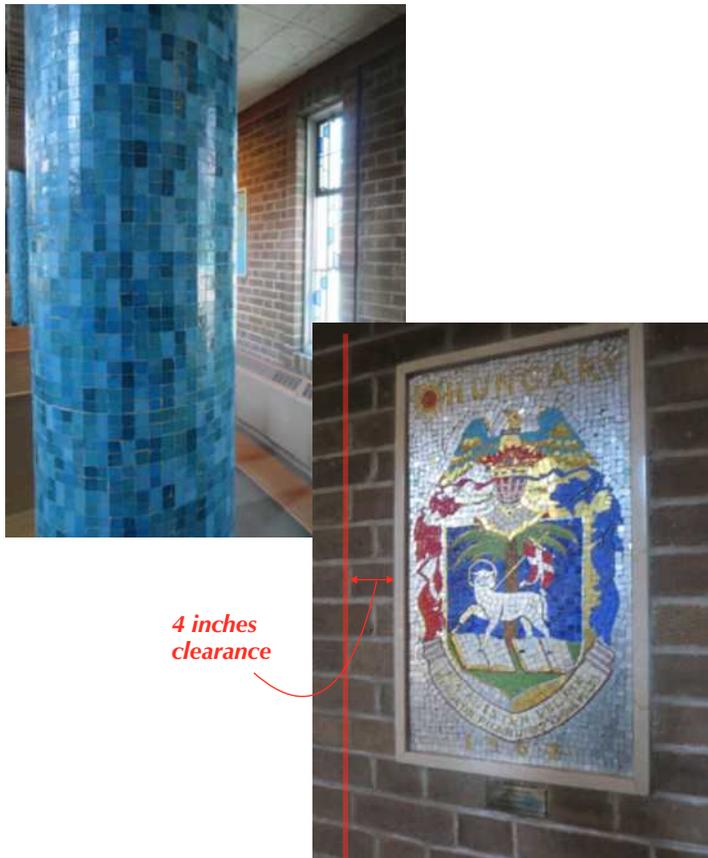
Overall interior view looking towards the south wall. Red annotations indicate the approximate areas of new floor slabs. Note the mosaic-tiled columns and inset plaques on the main level, which can be conserved.

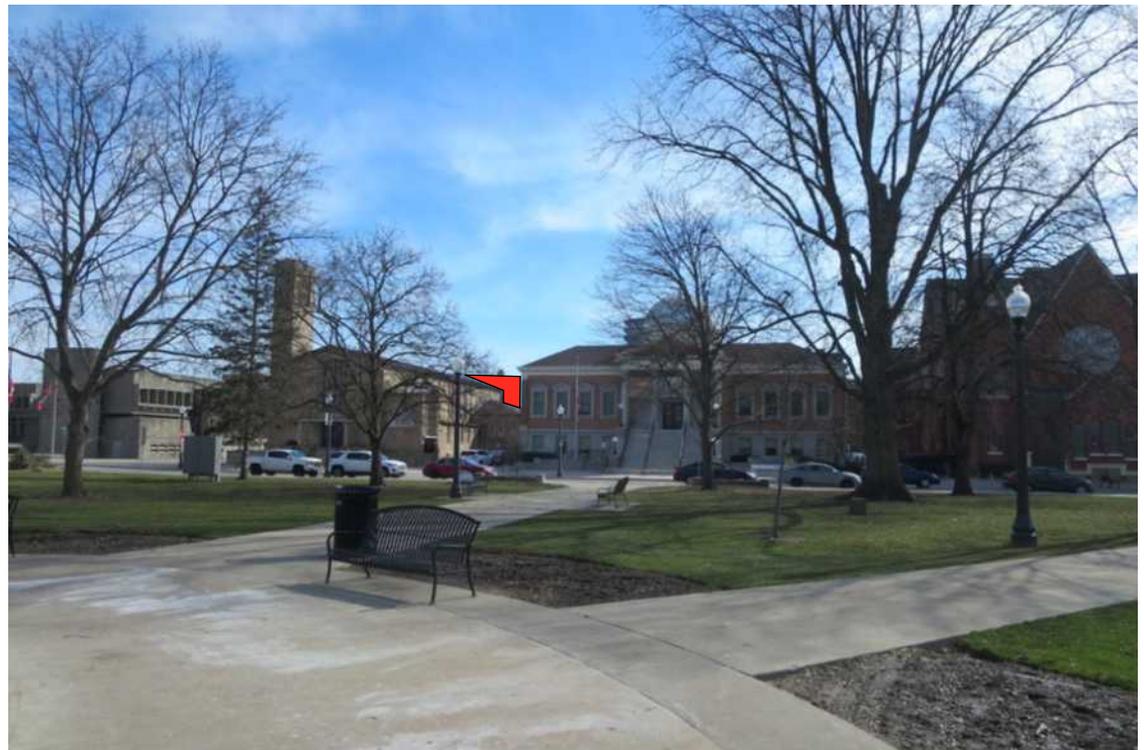
View from Victoria Square Park looking east towards the Central Presbyterian Church visible on the left. The additional third storey is graphically shown on the image. This addition's visual impact is minor and will not negatively affect the HCD's heritage value.

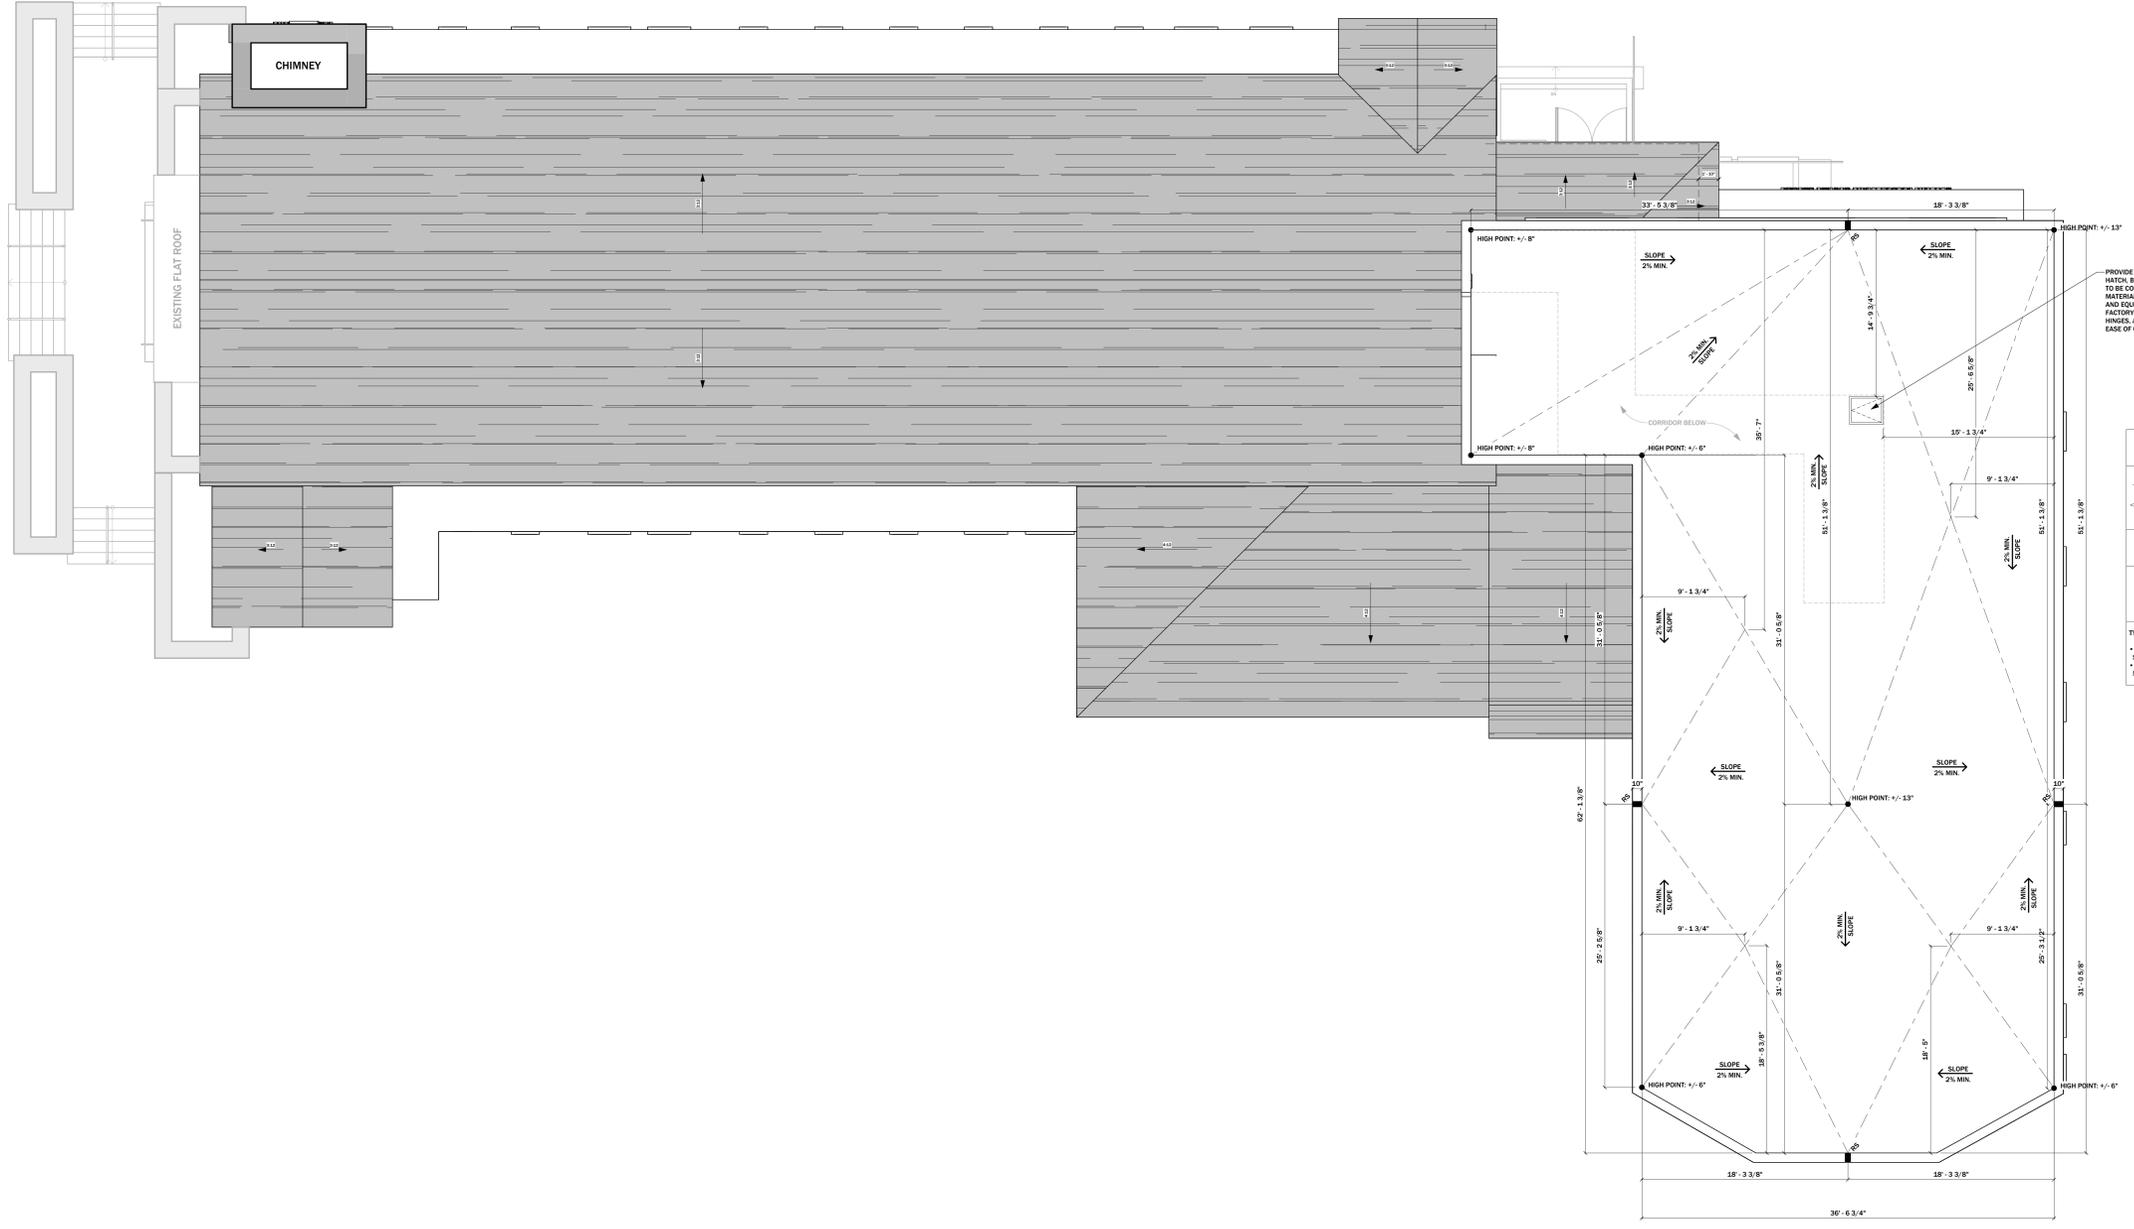
PROVIDE AND INSTALL PREFABRICATED ROOF ACCESS HATCH, BILCO MODEL OR APPROVED EQUIVALENT. HATCH TO BE CONSTRUCTED WITH CORROSION RESISTANT MATERIALS, INSULATED FOR THERMAL PERFORMANCE, AND EQUIPPED WITH A WEATHERTIGHT SEAL. INCLUDE FACTORY-INSTALLED SAFETY HOLD-OPEN ARM, HEAVY-DUTY FRINGES, AND COMPRESSION SPRING LIFT ASSISTANCE FOR EASE OF OPERATION.
