RE: Recommended Process for Brant War Memorial Monument, Park and WWII Monument Projects

Appendix B: Condition Assessment: Brant War Memorial

Artwork/Monument:	War Memorial
Artist:	Walter Seymour Allward
Date:	1933 Memorial Gallery 1954 Bronzes 1992
Date Assessed:	May 4 th , 2018
Location:	War Memorial Park Brant Ave. and West St.
GPS Coordinates:	43°8'31" N 80°16'9" W
Materials:	Bronze, Granite
Overall Dimensions:	Bronzes: 72" – 81" (h) x 22"-31" (w)

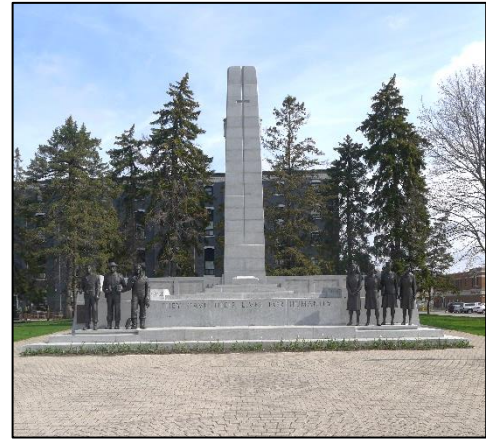
The large-scale War Memorial was conceived by W. S. Allward and built in 1933. It consists of a tall granite cenotaph that stands behind a tomb-shaped memorial stone at the centre of the monument. A memorial gallery was added to the back of the monument in 1954; it includes a tall granite back wall inscribed with the names of soldiers killed in the Second World War and the Korean War. In 1992, seven bronze figures were added to the front of the monument, representing members of the Canadian Army, Navy, Airforce, the Nursing Sisters of the Royal Canadian Medical Corps, the Women's Royal Canadian Naval Service, Canadian Women's Army Corps and the Royal Canadian Air Force Women's Division.

Overall Condition: Good

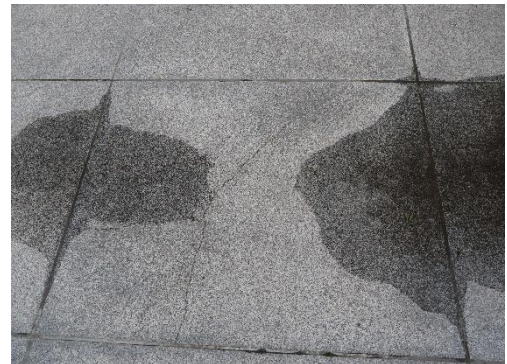
Of most concern are the drainage issues that impact the floor of the memorial gallery. Conditions have worsened since this problem was documented in the 2012 CSMO condition report. At the time of our assessment, water from overnight rain had pooled along the entire central length of the memorial gallery floor. The granite stones have shifted overtime creating a slight depression towards the centre of the floor. The existing floor drains are currently entirely ineffective, as they are situated at high points on the granite floor. Significant vegetative debris and soiling has built up around the two westernmost drains, rendering them even less functional. However, the exit points of the drainage system at the rear of the monument remain clear. As a result of these drainage issues, the caulking between the stones has failed in some locations. Moss growth was observed at several of the caulking lines. One of the granite stones towards the east end of the gallery has cracked (figure 1), likely due to increased water

Figure 1: Crack in granite stone in floor of the memorial gallery where water pools due to drainage issues.

penetration and freeze-thaw damage. The granite is also stained throughout the area where water pools, as a result of increased wet soiling build-up.

The caulking on the majority of the memorial requires replacement. Since the caulking on the cenotaph remains in fairly good condition, it could be replaced at a later date. The joints on the rest of the monument should be addressed in the next 1-2 years. Caulking should be removed, and the joints fully cleaned out and allowed to dry. Spalls in the granite along joint lines should be repaired at this time, using a compatible mortar to fill the losses. This will help reduce water

infiltration at the joint line and should extend the life of the new caulking. Where the granite is fractured but has not yet spalled, larger spalls should be secured and cracks filled with an appropriate repair material, and any fragmented granite consolidated. Once all repairs are complete and cured, the joints should be re-caulked with a flexible, UV stable sealant.

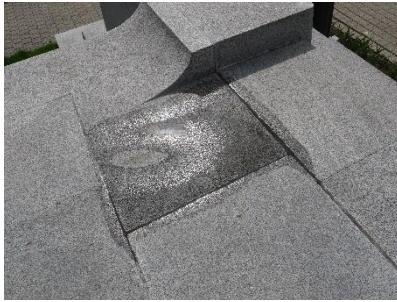
Figure 2: Stone at SW corner that has settled lower than the surrounding stones, creating a drainage issue.

A stone towards the front of the monument at the SW corner has also settled and suffers from drainage issues (figure 2). As in the memorial gallery, the pooling of water on the stone has resulted in increased soiling and staining of the stone.

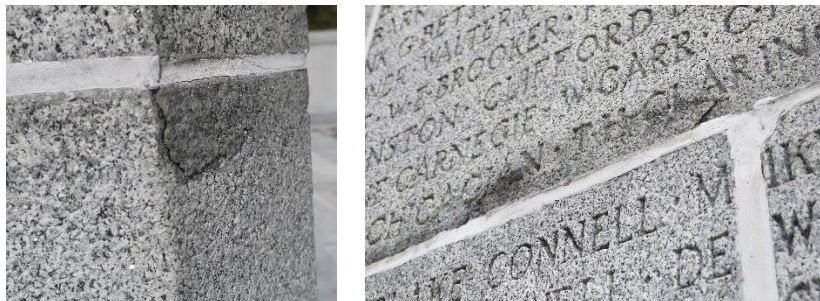
Previous repairs on the central cenotaph are visible and light in colour, but appear to be holding up quite well. There are several small spalls and fractures along caulking lines throughout the memorial, with the severity varying by location. Fewer spalls were observed on the central vertical cenotaph are generally minimal, with the most significant being at the NE corner (figure 3) and amongst the lettering on the west face (figure 4).

Figures 3 – 4: Fractures at the NE corner (left) and W face (right) of the central cenotaph that may soon lead to spalling

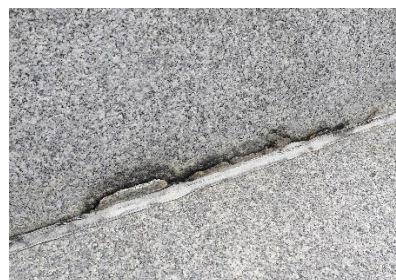
The caulking on the vertical joints of the cenotaph remains in fairly good condition. However, elsewhere on the monument where the caulking has deteriorated, more severe spalling was observed along the joints. The caulking has failed at the joint around the base of the stone of remembrance, leaving a gap between the caulking and the stone that has allowed for water ingress, insect burrowing (figure 5), and moss growth. Significant spalling is present along the SW portion of the joint (figure 6).

Figure 6: Spalling at SW joint of the stone of remembrance.

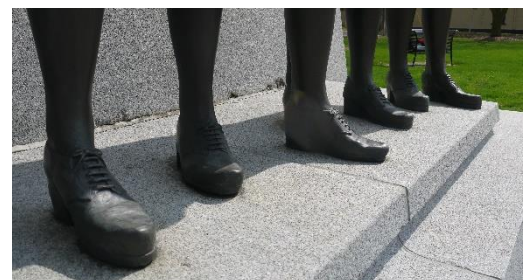
Figure 7: Stone spalling along joint at the base of the wall behind the figures' feet.

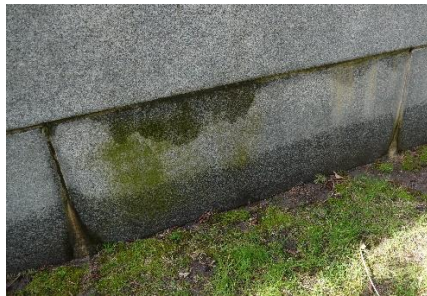
Failed caulking at lowest joints on the back side of the memorial gallery have resulted in heavy biogrowth, water saturation of the stone, and the buildup of salt efflorescence (figure 8). Intentional drainage holes are present in this caulking joint, but angled weep hole tubes were not used, and therefore the caulking below the holes has failed. Green biogrowth is also present along the top of this back wall. The wall is north facing and highly shaded by the adjacent evergreen trees (figure 9), which results in the stone remaining wet for longer periods of time.

Figure 8: Moisture, biogrowth and salt efflorescence a result of failed caulking at lowest joints on back side of memorial gallery.

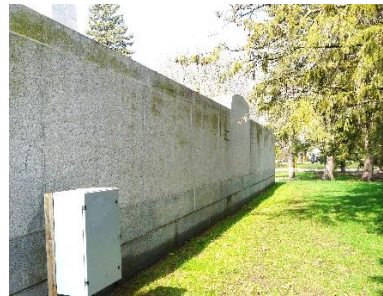
Figure 9: Biogrowth on the shaded, north-facing back wall of the memorial gallery.

The monument should be inspected annually, preferably in the spring, to review its condition along with the condition of any connection bolts, fasteners, or supports. The monument should be washed each spring using an anionic detergent, such as a solution of Orvus W A Paste, and rinsed with low-pressure water. Areas of the monument that tend to suffer from biological growth should be scrubbed clean each spring with a specialized detergent, such as D/2 Biological Solution.

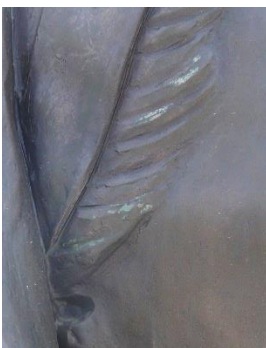
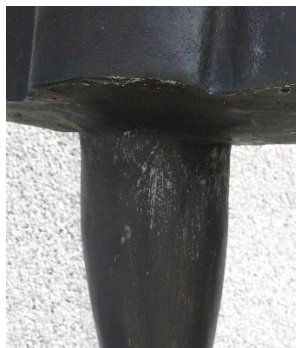
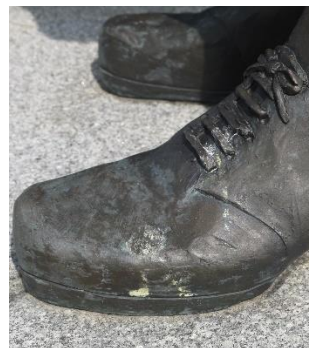
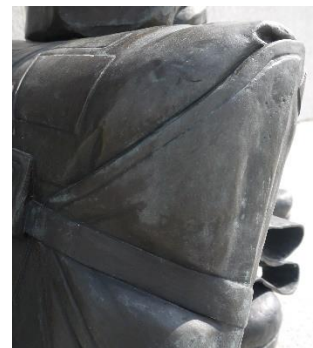
The bronze figures at the front of the monument remain in good condition. According to maintenance records from the client, their protective wax coatings were last renewed in 2015. The coating is holding up fairly well, but there are numerous areas where the protective coating has been disturbed, either from abrasion, scratches, bird droppings, or salt use, that has resulted in localized corrosion (figures 10-13).

Figures 10-13: Localized areas of corrosion on bronze figures due to abrasion, scratches, bird droppings, or salt use that have disturbed the protective wax coating.

The coating has worn down and blanched on the ground level elements, such as the figures' shoes and the pilot's bag (figure 13). Aside from these localized areas of deterioration, the overall patina of the sculptures remains a rich dark brown, and the surfaces are still nicely polished and saturated from the recent wax coating. The sculptures are clean overall, with localized residual bird droppings and insect frass. The weep holes on the sculptures are all well-situated and for the most part clear of debris.

The bronze torch holders in the memorial gallery require cleaning, removal of failed coatings, and re-patination. A new wax or lacquer protective coating should be applied. The bronze figures at the front of the monument remain in good condition. If regularly cleaned, the renewal of their protective wax coating can wait another 2-3 years.

Wax coatings should be inspected once per year for deterioration. Generally, wax coatings should be renewed every 1-3 years. Coating renewal should be done by or in consultation with a conservator. Prior to the renewal of a wax coating, the aged/failed coating and any corrosion should be removed, and the artwork should be thoroughly cleaned. A custom-formulated hot wax coating should be applied that is consistent with industry standards and appropriate for local weather conditions. To ensure a full and uniform coating, two applications of the hot wax coating should be applied followed by a cold application of a paste wax. If deterioration to the surface coating or decorative finish is observed, the object should be re-evaluated by a conservator.

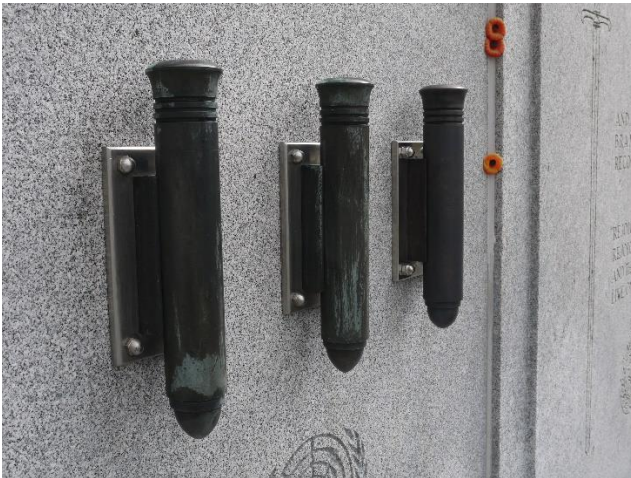
In the memorial gallery, the six bronze torch holders shaped like gun shells are suffering from corrosion where their protective coatings have failed (figure 14). Brush-like marks of surface corrosion indicate that the protective wax was either not applied hot, or the metal was insufficiently heated during application and the surface was coated unevenly. Corrosion has progressed further on the skyward surface of the bronze mounts that brace the torch holders (figure 15). The stainless steel mounting panels are in good condition, although some ferrous corrosion and corrosion staining is visible at points around the bolts. The backs of these bolts are accessible in drilled holes in the granite at the back side of the memorial gallery. Most of these bolts have rubber washers that help seal the bolt from water infiltration, however, some of these washers are missing and one has been replaced with electrical tape.

Figure 14: Surface corrosion due to failed wax coating on bronze torch holders in the memorial gallery.

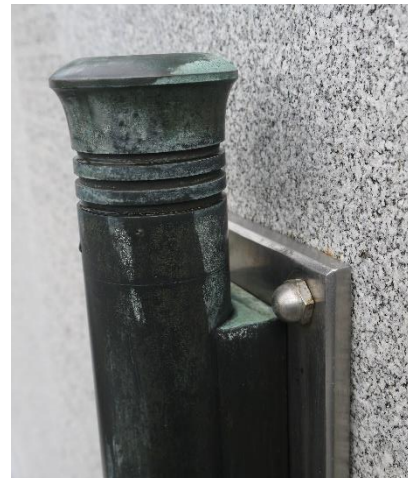
Figure 15: Detail showing surface corrosion on the skyward surface of the bronze mount.
