Appendix D: Heritage Attributes of 53 Charlotte Street

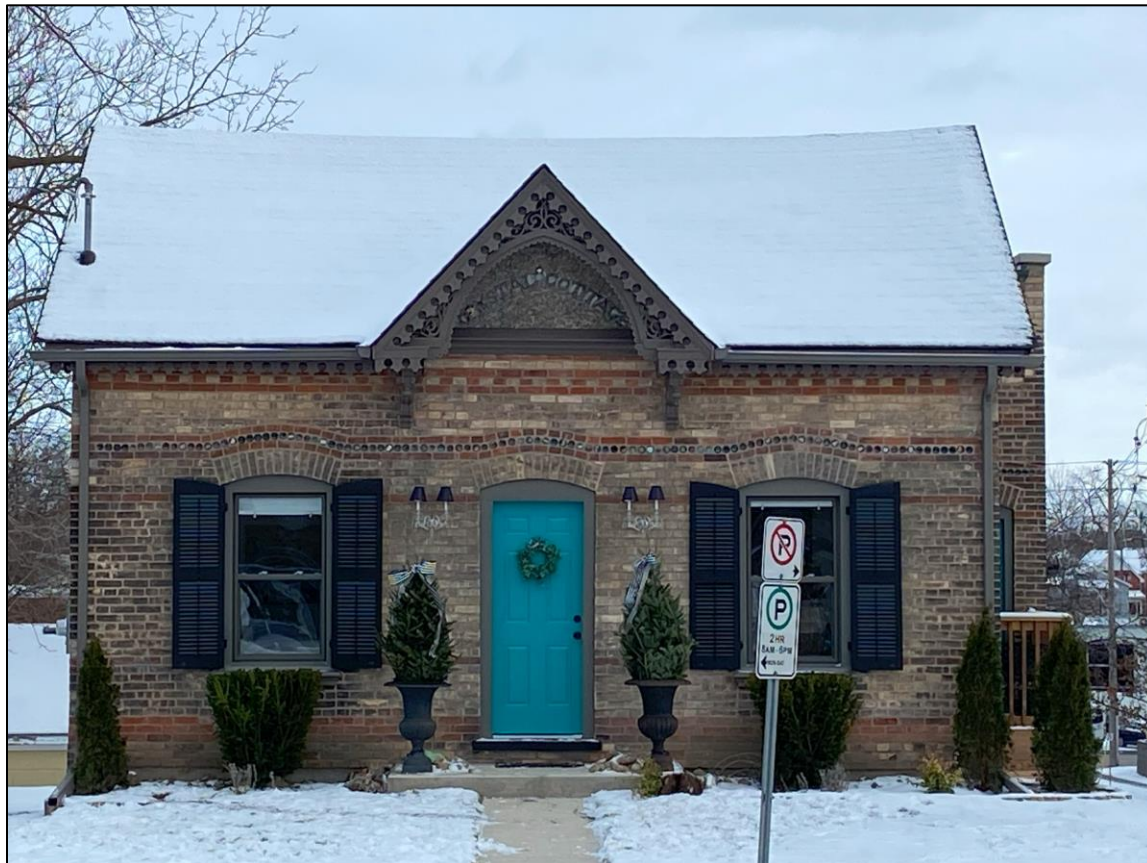
Figure 1: The restored Crystal Cottage at 53 Charlotte Street with the front façade as seen from Charlotte Street.

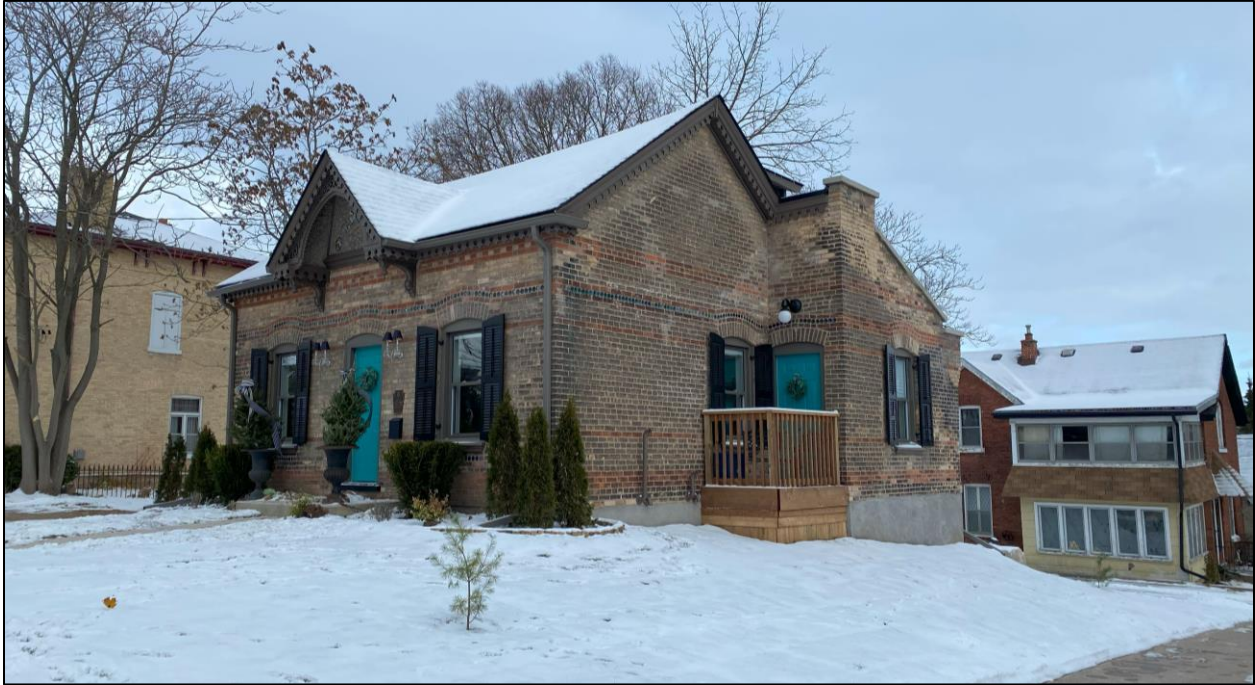
Figure 2: View of 53 Charlotte Street and the restored Crystal Cottage from the corner of Charlotte Street and Wellington Street. The front and right (south) side façades can be seen in this image.

- Wooden windowsills and wooden shutters on the front and right-side (south) façades.

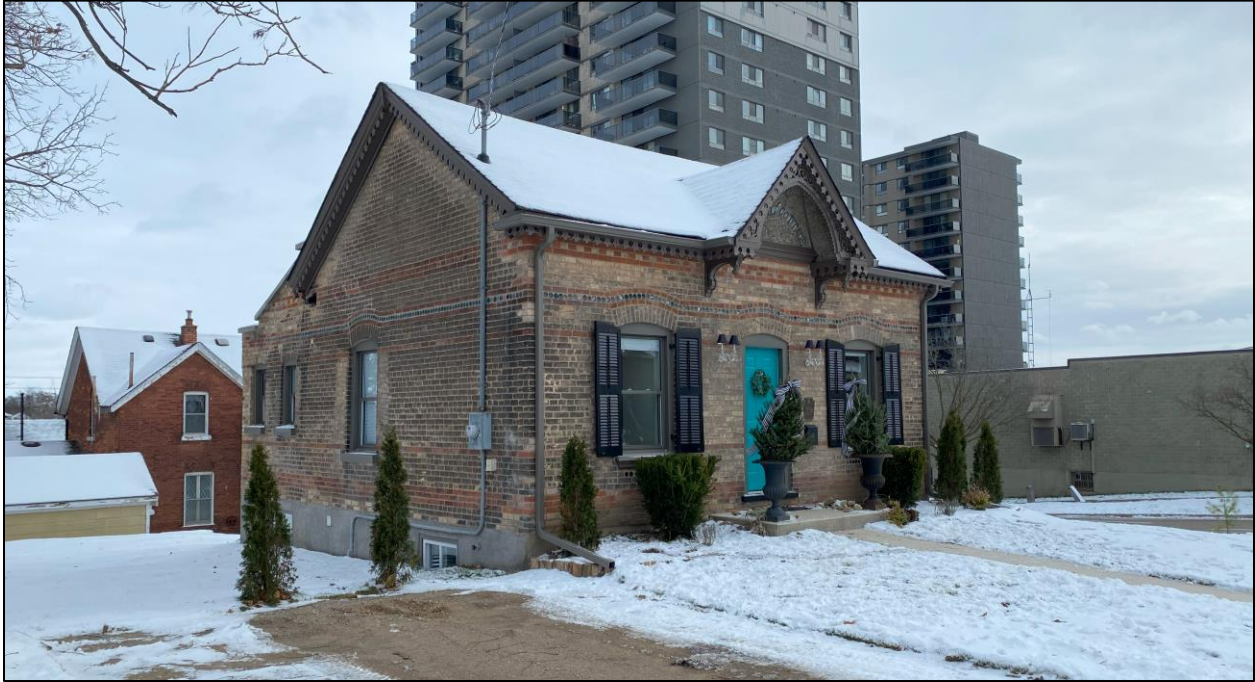
Figure 3: View of 53 Charlotte Street and the restored Crystal Cottage showing the front and left (north) side façades.

- Runs the full length of the left side façade.
 - Runs the full width of the front façade, only being interrupted at the front corners by a red closer brick at either end.

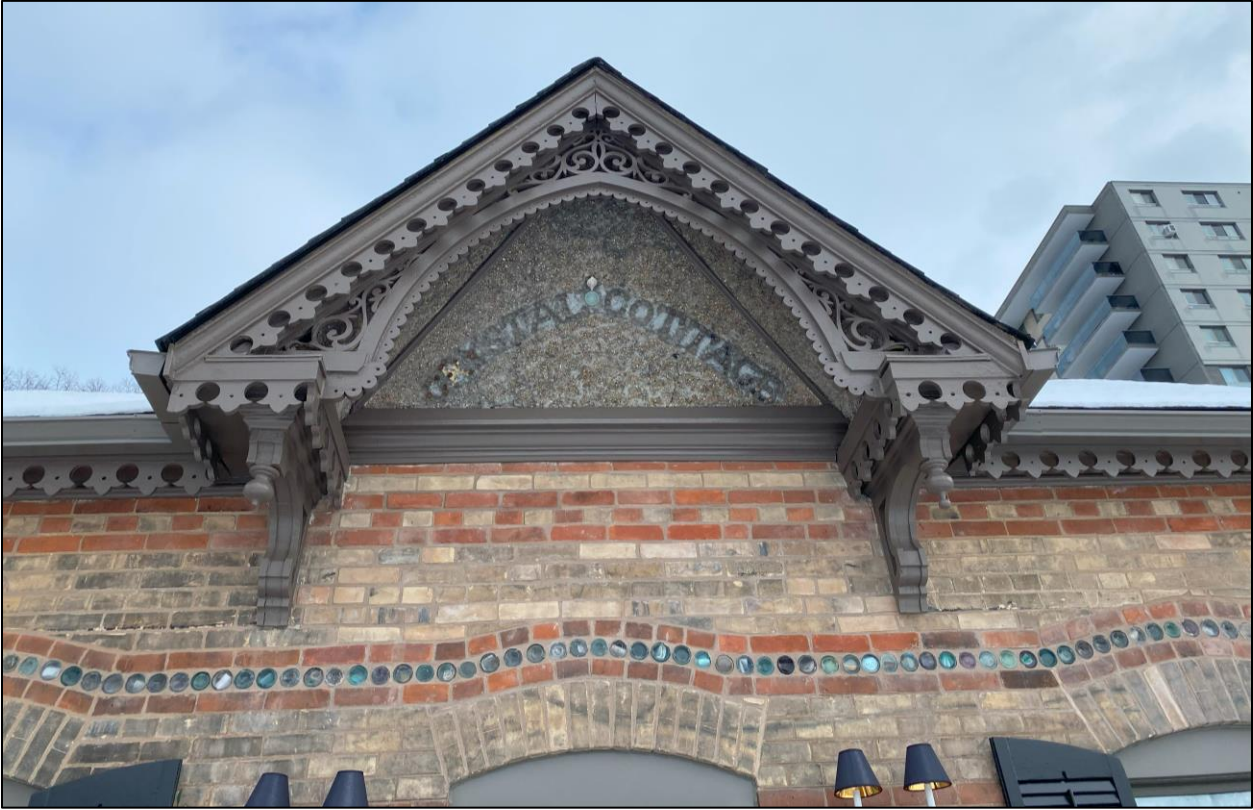
Figure 4: Close-up of the front gable showing the words "CRYSTAL COTTAGE" as well as ornate wooden trim. On the brick wall below, part of the polychromatic brickwork is visible together with the course of glass bottles.

- A pebbledash coating in the front gable, with the name “CRYSTAL COTTAGE” set in an arc and originally spelled out with chestnuts. A glass roundel sits between the words “CRYSTAL” and “COTTAGE” and above that is a seashell.

- Ornate wooden trim in the eaves, consisting of:
 - On the front and side facades, including in the gable eaves, fascia cut to feature a fleur-de-lis motif.

- Two, single ornate brackets supporting the front gable.
 - Vergeboard in the front gable in the shape of a pointed arch, with the inside edged having semi-circular details and the body of the vergeboard cut to have a vine motif.

- Framing the pebbledash from below, a decorative wooden band with a complex profile.
- Dichromatic brick walls (buff, with red accents) in common bond, with the following decorative accents:

- On the front and side facades, a course of glass bottles (base facing out) set between two rows of red brick in stretcher course except for over window or door openings where the red brick is laid in header course. This course:
