Appendix D: Heritage Attributes of 53 Charlotte Street

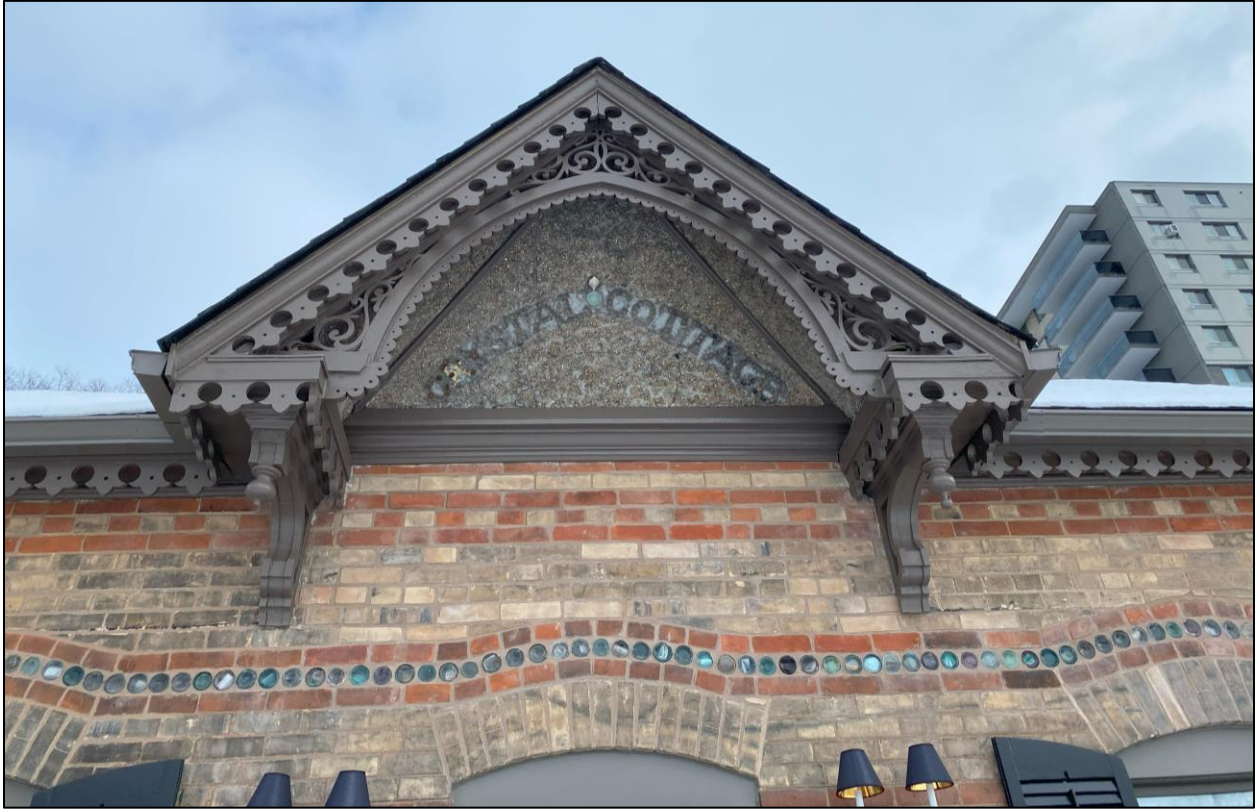
Figure 4: Close-up of the front gable showing the words "Crystal Cottage" as well as ornate wooden trim. On the brick wall below, part of the polychromatic brickwork is visible together with the course of glass bottles.

- A pebbledash coating in the front gable, with the name “Crystal Cottage” set in an arc and originally spelled out with acorns. A glass roundel sits between the words “crystal” and “cottage” and above that is a seashell.

- Ornate wooden trim in the eaves, consisting of:
 - On the front and side facades, including in the gable eaves, fascia cut to feature a fleur-de-lis motif.

- Two, single ornate brackets supporting the front gable.
 - Vergeboard in the front gable in the shape of a pointed arch, with the inside edged having semi-circular details and the body of the vergeboard cut to have a vine motif.

- Framing the pebbledash from below, a decorative wooden band with a complex profile.
- Dichromatic brick walls (buff, with red accents) in common bond, with the following decorative accents:

- On the front and side facades, a course of glass bottles (base facing out) set between two rows of red brick in stretcher course except for over window or door openings where the red brick is laid in header course. This course:
